Total Home Inspection LLC

Inspection Report

Client: Edgar Nunez
822 Beacon Pkwy E Unit A
Birmingham, AL 35209

Report: 06nunez1919

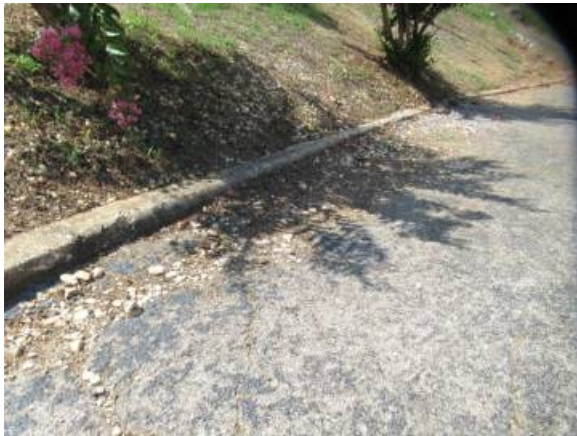
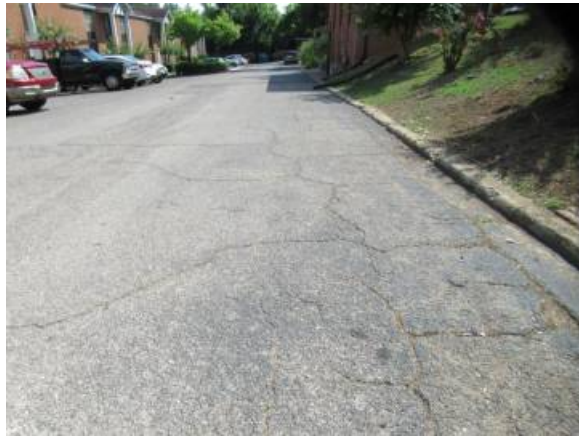
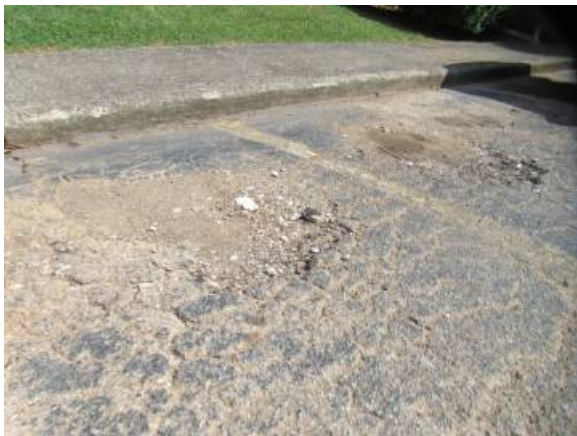
☐ ☒ ☐ ☐ Type: Asphalt. Common parking area. The asphalt parking lot was due for maintenance and resurfacing.

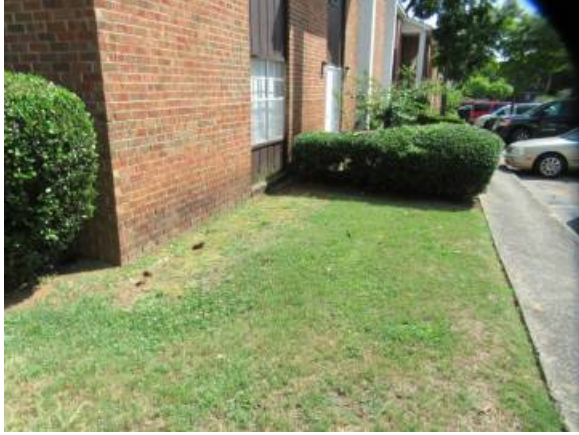
☐ ☒ ☐ ☐ Slope: Moderate. The soil in the front should be graded to slope away from the building at the left end to help prevent issues related to water at the foundation. This did not appear to directly affect the unit inspected.

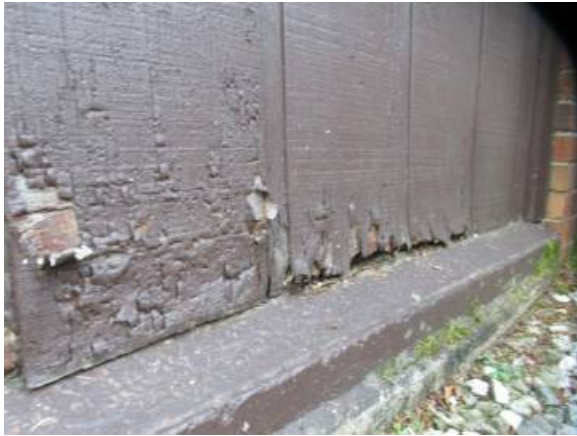
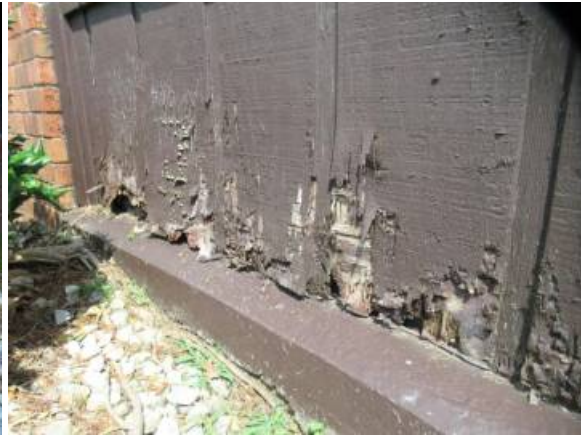
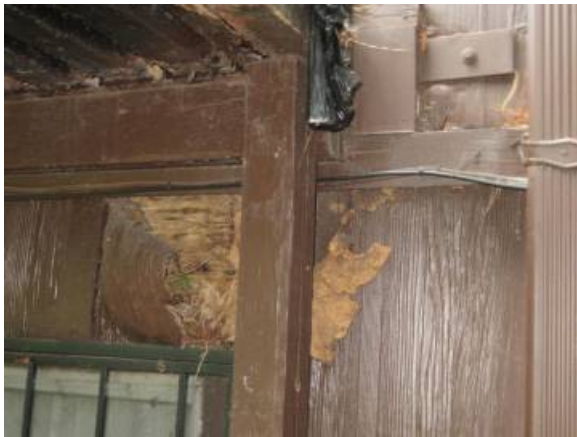
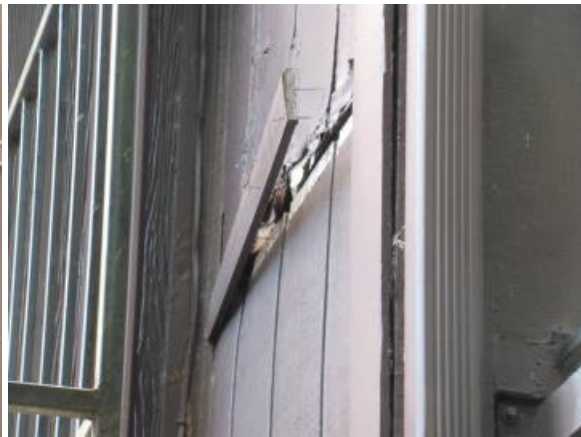
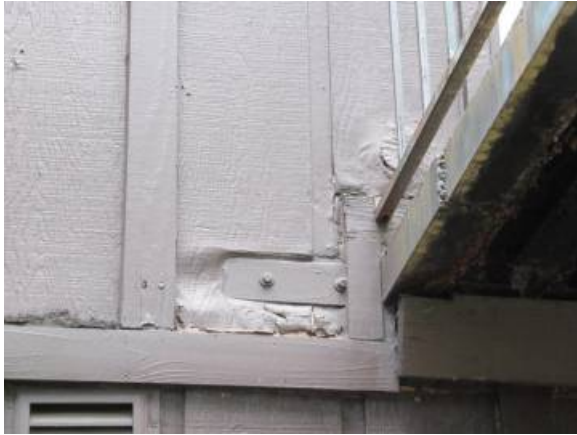
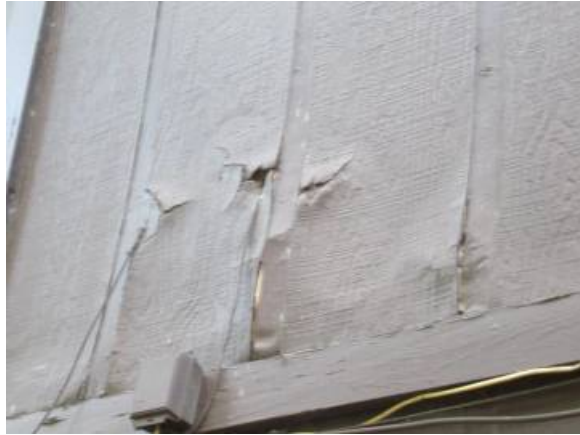
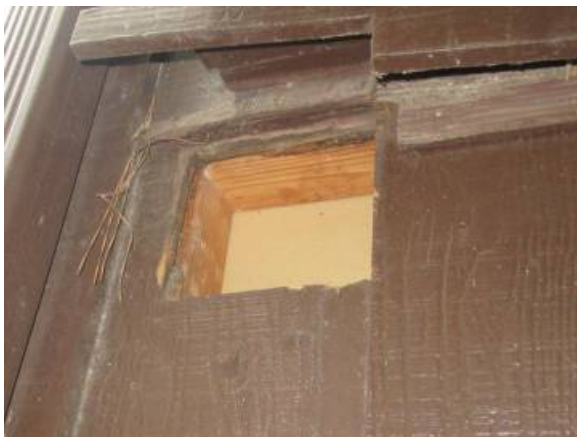
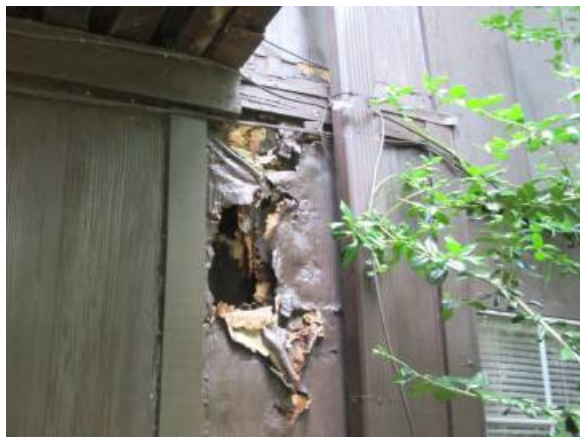
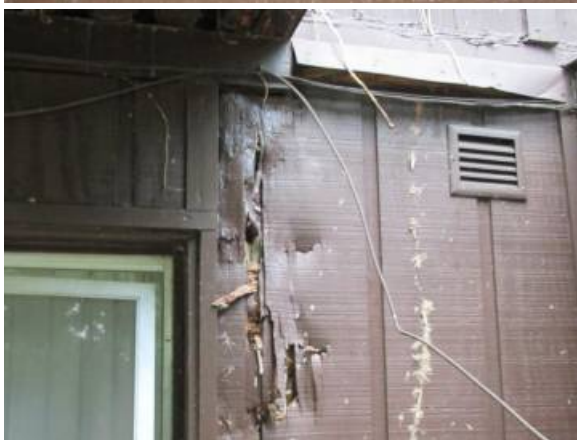
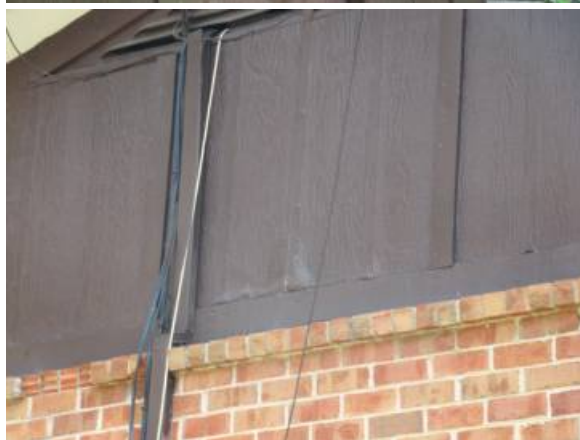
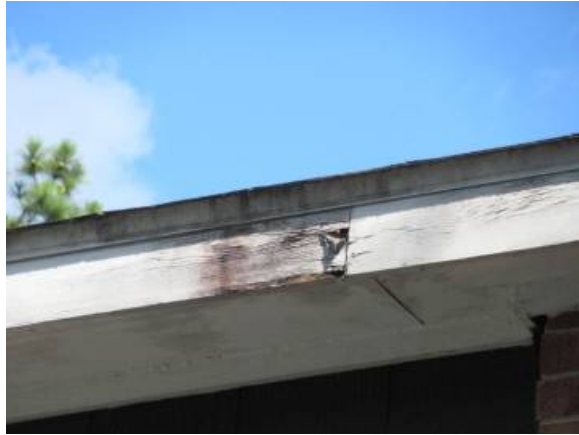
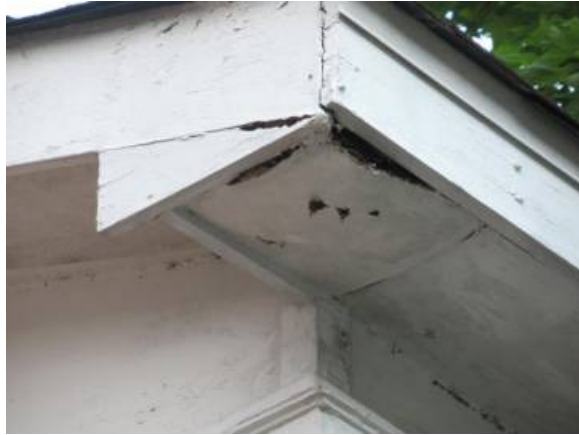
There was deteriorated wood in need of replacement in a multitude of locations around the buildings, and proper flashings are needed around the balconies. Some assessment may be needed to rectify this deferred maintenance to help prevent further damage and mold inside the walls.

OK	MM	RR	SAF	
Wall Materials:	<input checked="" type="checkbox"/>	<input type="checkbox"/>	<input type="checkbox"/>	<input type="checkbox"/>	Wall Materials: Brick and Plywood.
Wall Condition:	<input type="checkbox"/>	<input type="checkbox"/>	<input checked="" type="checkbox"/>	<input type="checkbox"/>	There was deteriorated wood in need of replacement in a multitude of locations around the buildings, and proper flashings are needed around the balconies. Some assessment may be needed to rectify this deferred maintenance to help prevent further damage and mold inside the walls.

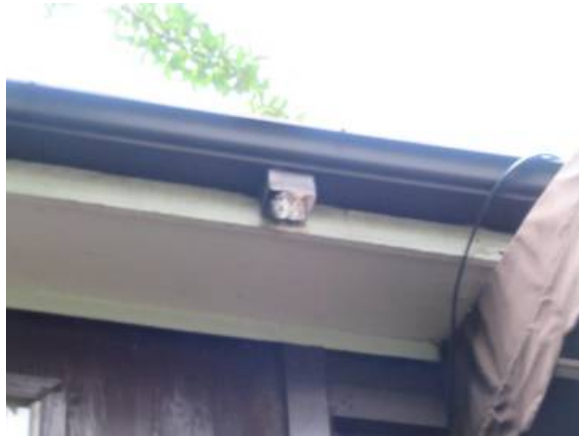
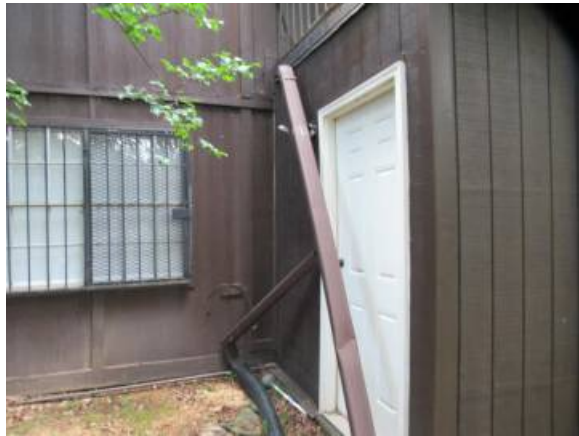
The downspout was disconnected and should be re-secured to the gutter at the rear.

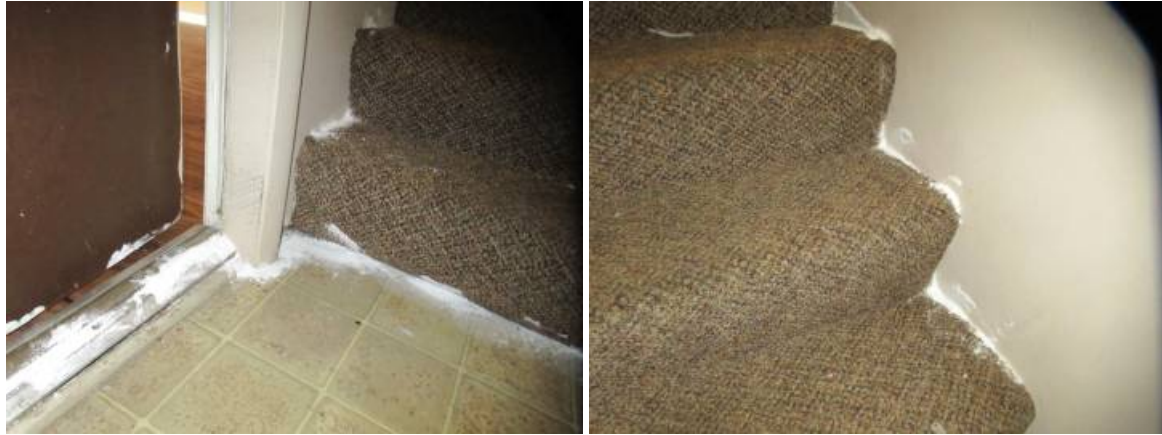
There was a white powder substance present on the interior steps and at the threshold for the inspected unit. This was purported to be pest control measures (boric acid powder) and could pose a hazard to small children (if crawling and rubbing eyes, swallowing, etc.) if it is poisonous. Removal is recommended, and the HOA should be contacted to determine the type substance.

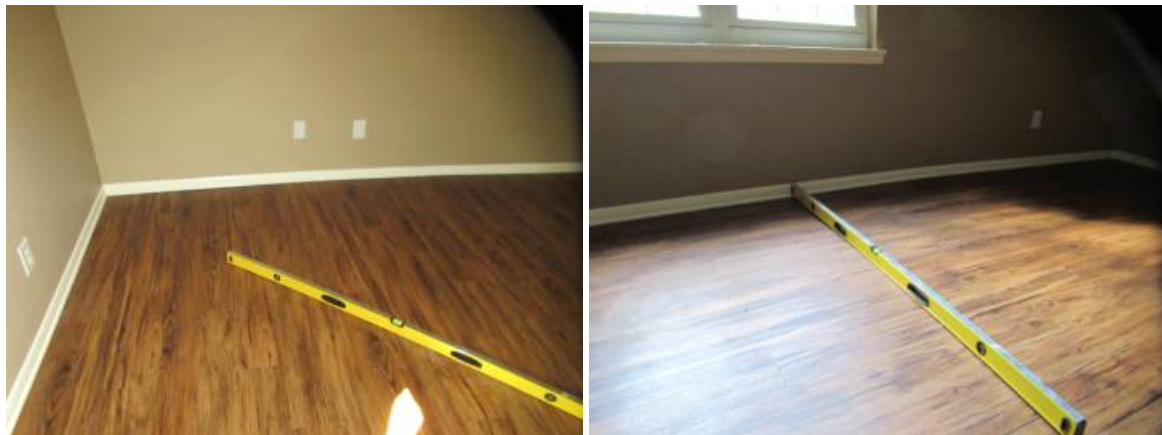
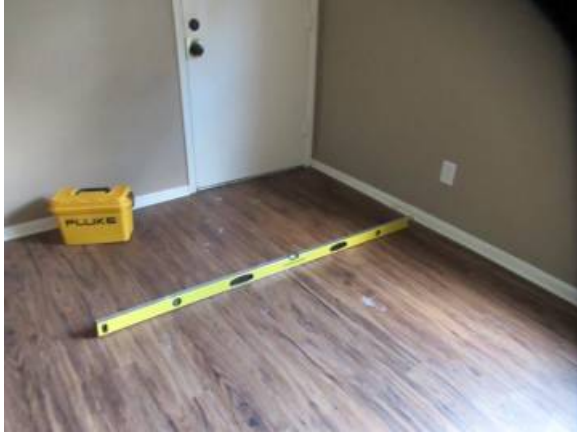
The foundation was a poured in place concrete slab. Perimeter visibility: Not Visible. The slab was not fully visible due to floor coverings. The slab had an excessive slope toward the front wall. There were no other signs of settlement viewed such as cracking in the walls and ceilings in this area. However, this could still be due to settlement, and foundation repairs may be needed. Further evaluation by a structural engineer is recommended.

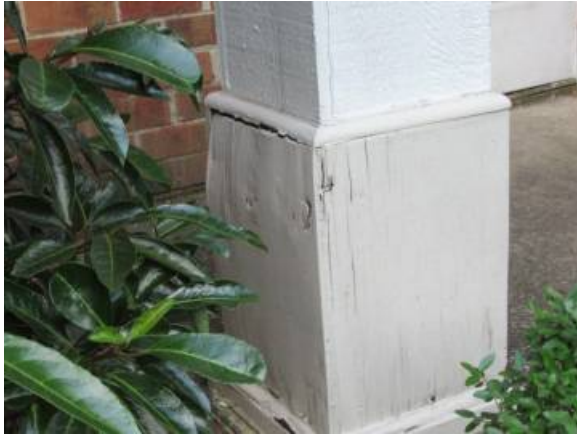
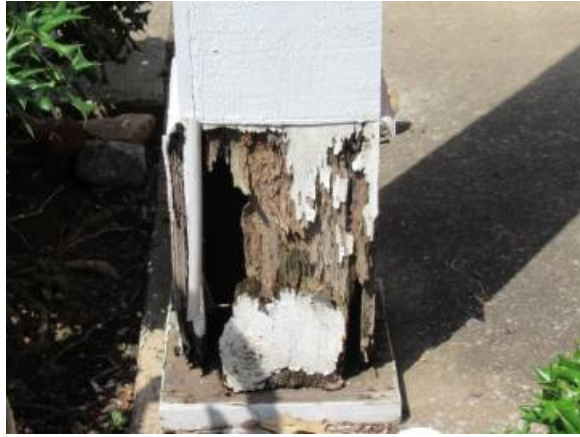
Roof Support Columns:
☐ ☐ ☒ ☐ There was deteriorated wood in need of replacement on some of the front roof columns.

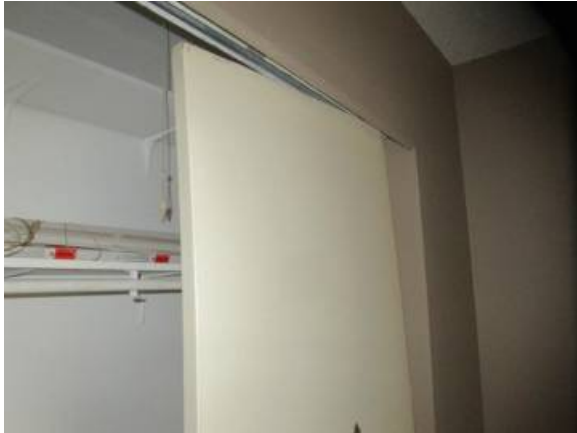
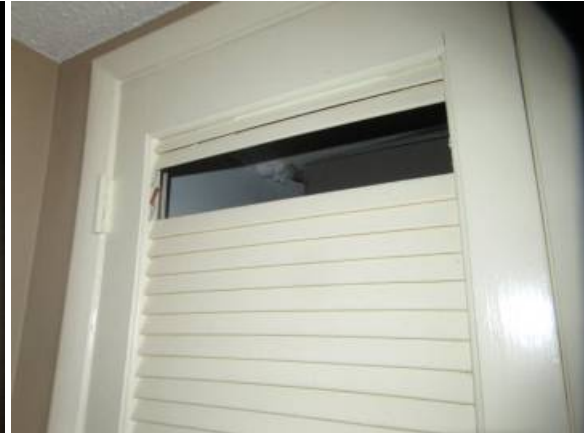
OK	MM	RR	SAF	
<i>Exterior & Entry Doors:</i>					
<input checked="" type="checkbox"/>	<input type="checkbox"/>	<input type="checkbox"/>	<input type="checkbox"/>		Hardware operational. Weather stripping appears serviceable.
<i>Interior Doors:</i>					
<input type="checkbox"/>	<input type="checkbox"/>	<input checked="" type="checkbox"/>	<input type="checkbox"/>		A representative sampling of doors throughout the house were tested. There was door damage noted at the utility closet. The bedroom closet doors were off track and in need of adjustment.

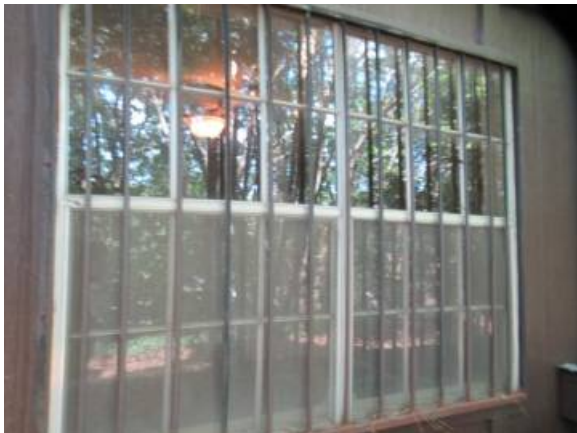
<i>Type & Material:</i>					
<input checked="" type="checkbox"/>	<input type="checkbox"/>	<input type="checkbox"/>	<input type="checkbox"/>		Material: Vinyl and Aluminum. Type: Double hung.
<i>General Condition:</i>					
<input type="checkbox"/>	<input type="checkbox"/>	<input type="checkbox"/>	<input checked="" type="checkbox"/>		A representative sampling of windows throughout the house were tested. There were security bars present that were not openable. It is recommended that security bars be openable without the use of a key for fire egress safety purposes.

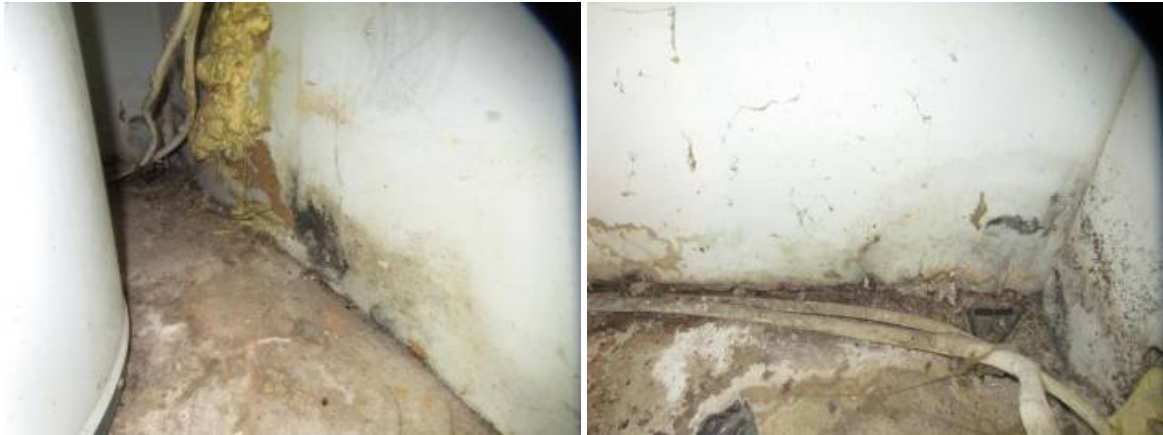
<i>Material:</i>					
<input checked="" type="checkbox"/>	<input type="checkbox"/>	<input type="checkbox"/>	<input type="checkbox"/>		Type: Drywall.
<i>General Condition:</i>					
<input type="checkbox"/>	<input type="checkbox"/>	<input type="checkbox"/>	<input checked="" type="checkbox"/>		There was a possible mold-like substance noted on the drywall in the utility

closet. Drywall replacement is likely needed as a part of the remediation process. Further evaluation and repairs as needed is recommended by a qualified contractor.

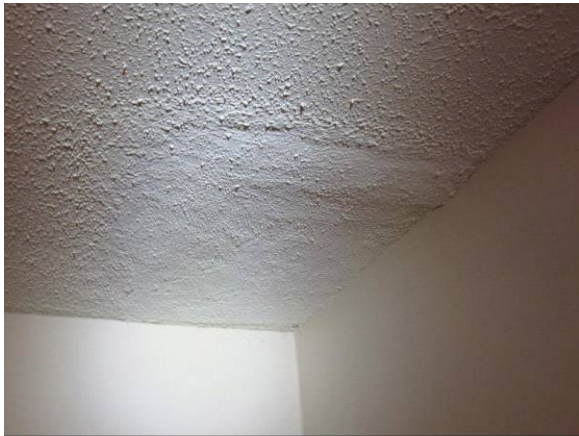
OK	MM	RR	SAF	
Materials:	<input checked="" type="checkbox"/>	<input type="checkbox"/>	<input type="checkbox"/>	<input type="checkbox"/>	Type: Drywall with acoustic spray. Note: Many ceilings with acoustic spray could contain asbestos. It is advisable to have them tested if removing the textured spray (and protocols followed if tests are positive).
General Condition:	<input type="checkbox"/>	<input type="checkbox"/>	<input checked="" type="checkbox"/>	<input type="checkbox"/>	Cosmetic repairs were noted to the ceilings in a few areas. Additional repairs and paint are advisable for a more uniform cosmetic appearance. There was damage in need of repair at the kitchen ceiling. There were stains with a mold-like substance at the ceiling in the bathroom. Removal/replacement of the affected drywall is recommended for remediation of the organic growth. There were indications of active leaking in these areas, and drywall repairs should be performed once leaks are repaired in the upstairs unit. Further evaluation and repairs as needed are recommended by a qualified contractor.

Repairs

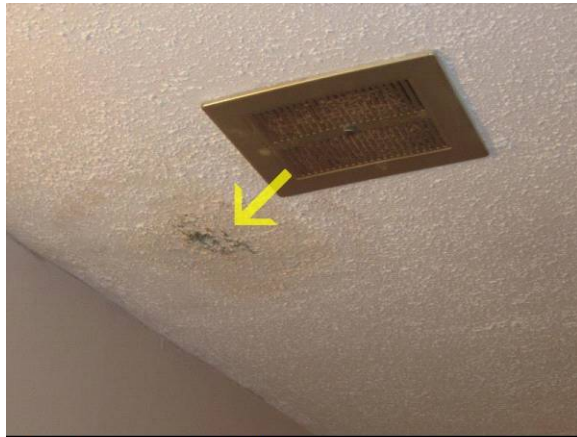
Replace - Mold

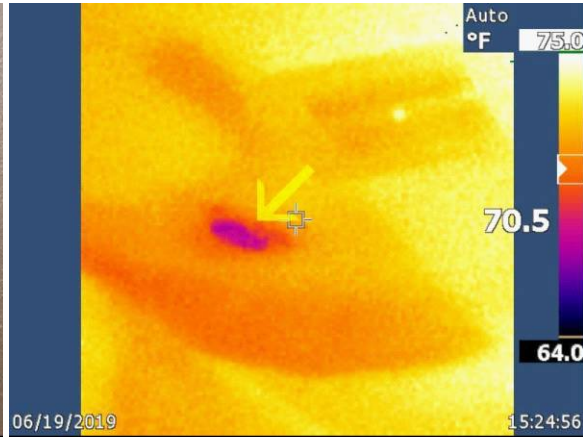
Active Leaking

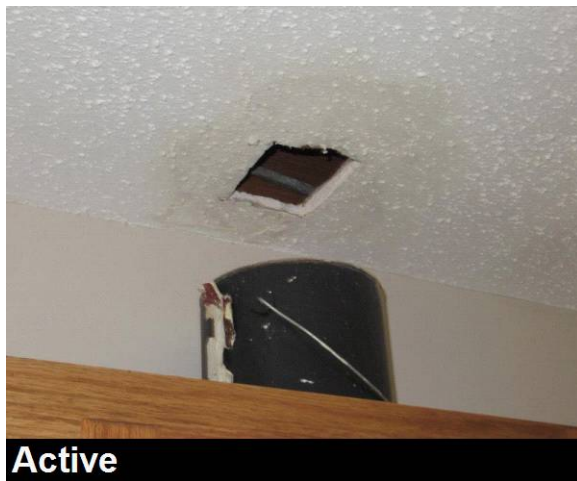
Active

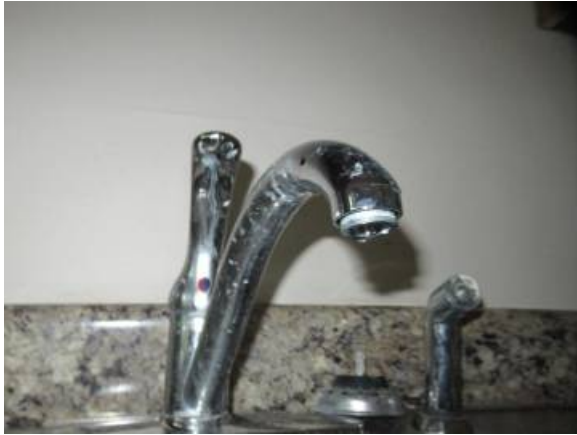
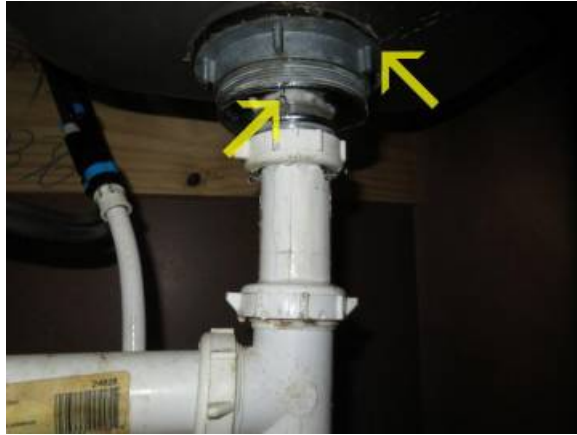
Type: Stainless Steel. The aerator screen was missing on the faucet. There was a leaking at the right drain line under the kitchen sink. Repairs should be made by a licensed plumber or qualified contractor.

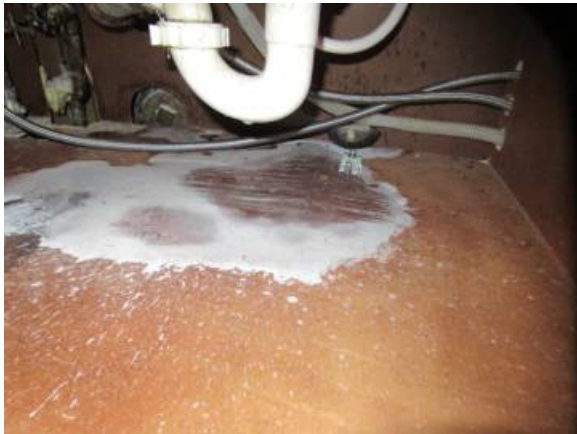
Type: Laminate. There was moisture damage to the cabinetry under the kitchen sink.

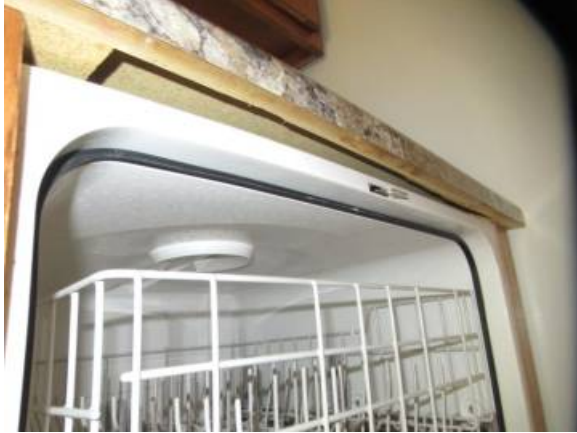
Drain line installed: High loop method. The dishwasher was not properly secured to the cabinetry.

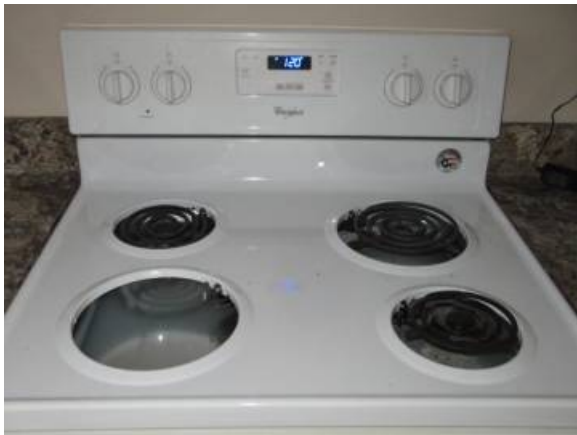
Type: Electric, The anti-tip protection device was not installed as per the manufacturer's installation instructions. The drip pans for the range burners were missing and in need of replacement. The left-front element was missing and should be replaced on the range.

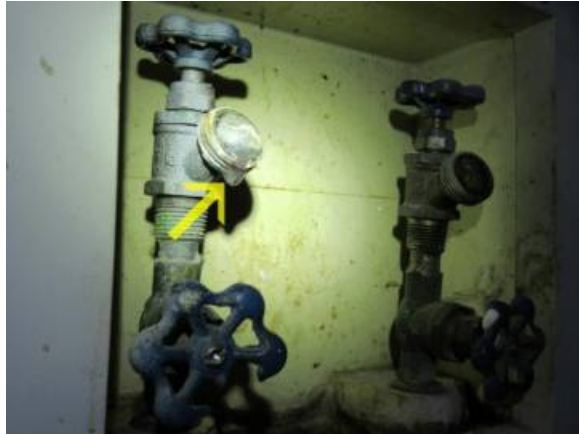
The water supply valve for the washing machine was dripping.

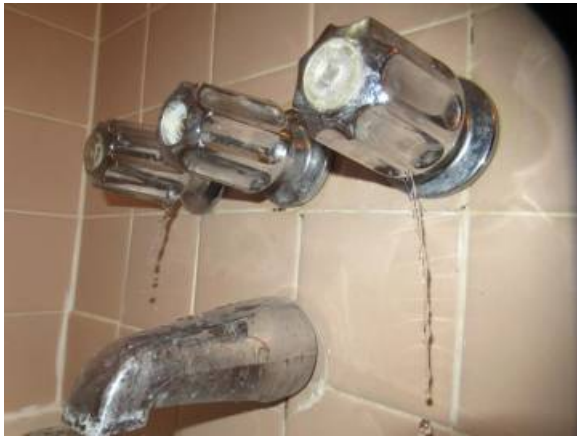
The drains appeared serviceable. Leakage was noted at faucet handles for the bathtub. Minor plumbing repair is recommended.
