Total Home Inspection LLC

Inspection Report

Client: Eric Fogle
825 81st St S
Birmingham, AL 35206

Report: 02fogle2619

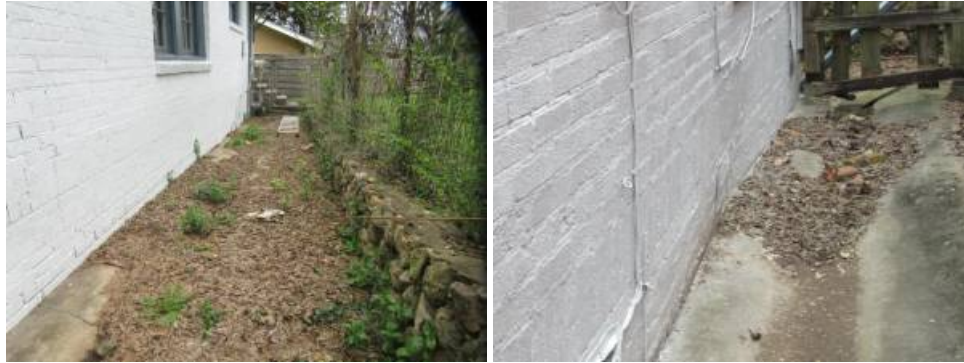
Slope: Moderate. The soil should be graded to slope away from the structure to help prevent moisture at the foundation. Some measures had been taken to help divert water away, but the hardscape at the rear appeared to have a slope toward the house. Additional measures appear to be needed to help prevent moisture intrusion at the foundation wall. Further evaluation and repairs as needed are recommended by a qualified contractor.

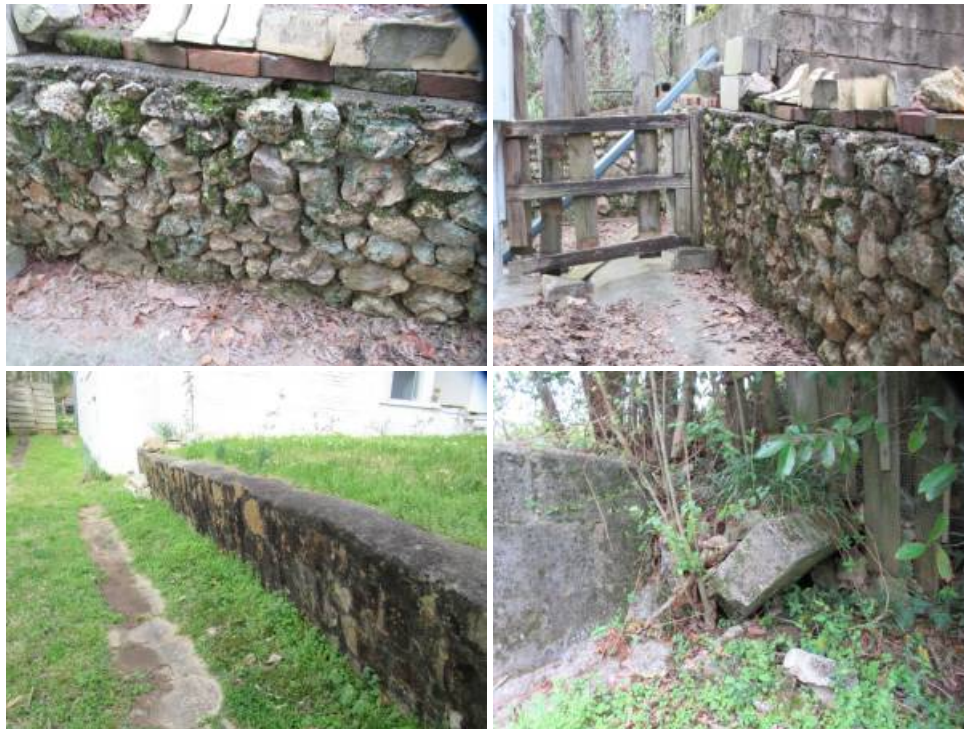
The masonry block retaining wall was collapsed at the right rear. Replacement is recommended in this area. Further evaluation and repairs as needed are recommended by a qualified contractor.

Retaining wall type: masonry block and stone. The stone retaining walls were cracked and leaning inward. Some mortar repairs had been made. This should be monitored for further movement and repairs made if additional movement occurs. The masonry block retaining wall was collapsed at the right rear. Replacement is recommended in this area. Further evaluation and repairs as needed are recommended by a qualified contractor.

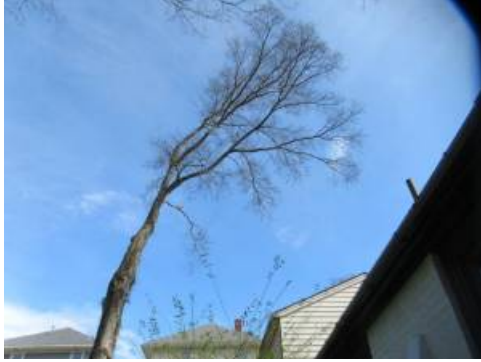
There was a large tree at the rear that appeared to have suffered severe injury from ivy growth and was now leaning towards the house. Removal of this tree is recommended.

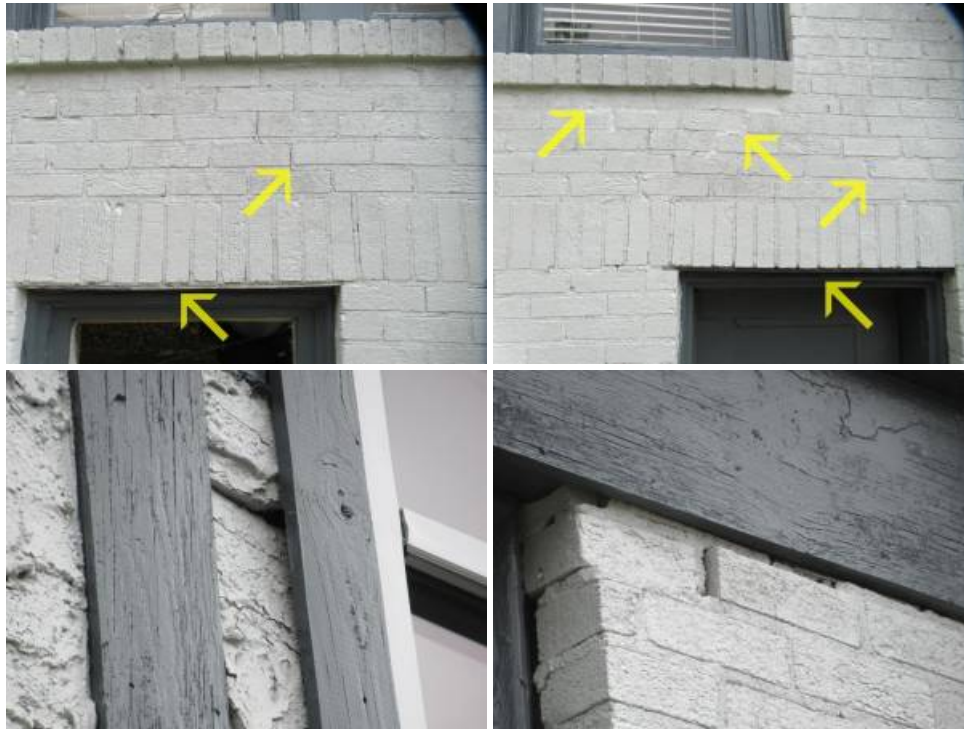
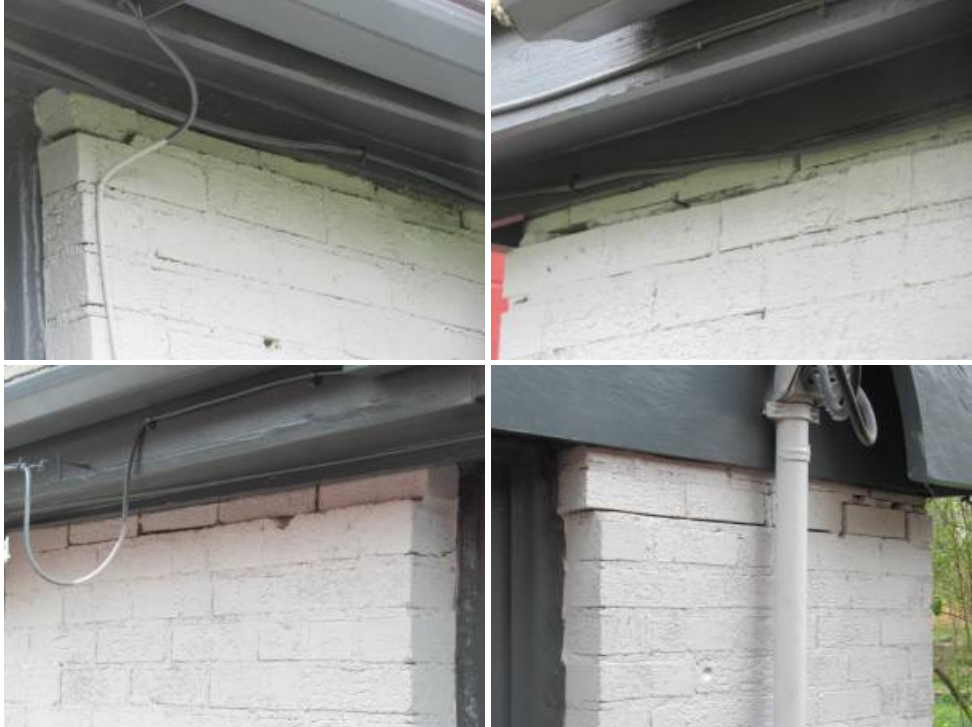
OK	MM	RR	SAF	
Wall Materials:	<input checked="" type="checkbox"/>	<input type="checkbox"/>	<input type="checkbox"/>	<input type="checkbox"/>	Wall Materials: Brick and Stucco.
Wall Condition:	<input type="checkbox"/>	<input type="checkbox"/>	<input checked="" type="checkbox"/>	<input type="checkbox"/>	There appeared to be some sagging in the lintels over the crawlspace door and window causing some cracking in the bricks above. This should be monitored for further movement and repairs made as needed. There was wall damage in need of repair at the stucco beside the upstairs window at the left side of the house. The top course of brick had broken from the wall in a few areas. Mortar repairs are recommended for any loose bricks.

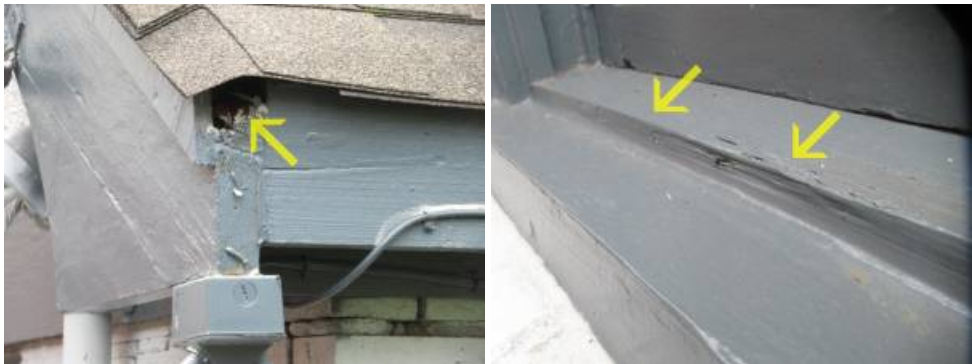
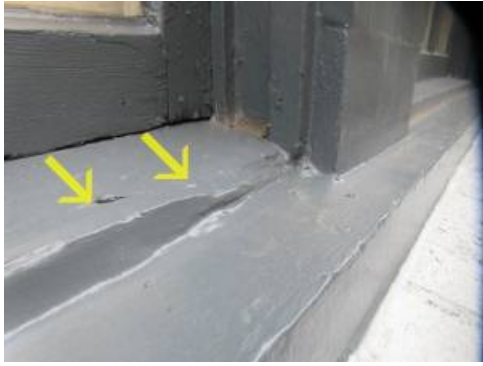
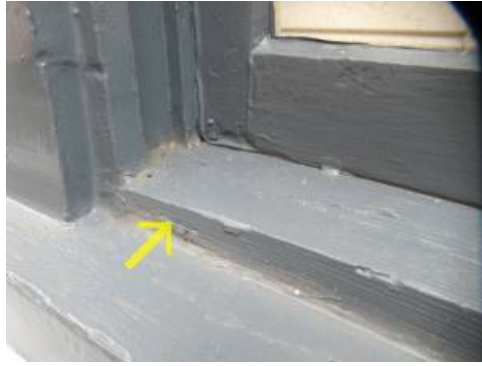
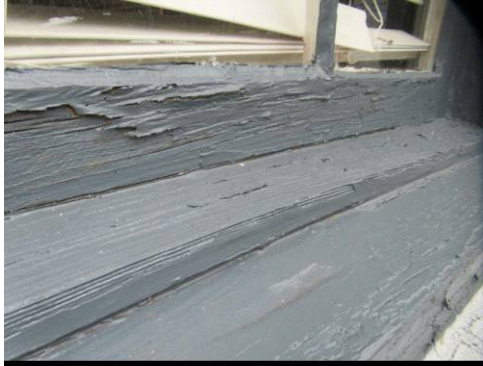
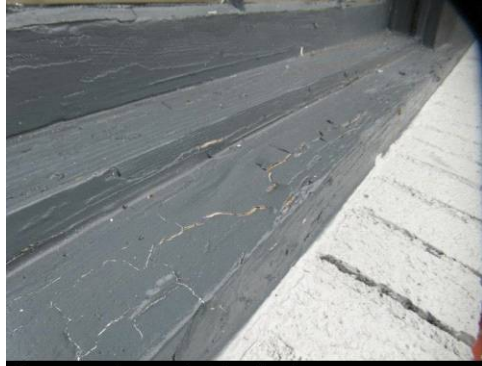
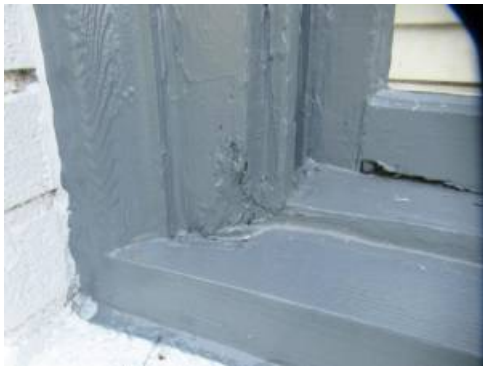
There was deteriorated wood/trim noted at the right-rear rafter/fascia and around a couple windows at the right side and rear. There was deteriorated wood that had been painted over in some locations, and additional deterioration may exist in other areas. Any/all deteriorated wood should be removed and replaced.

Paint and general maintenance is due around the front windows. There was deteriorated wood/trim noted at the right-rear rafter/fascia and around a couple windows at the right side and rear. There was deteriorated wood that had been painted over in some locations, and additional deterioration may exist in other areas. Any/all deteriorated wood should be removed and replaced.

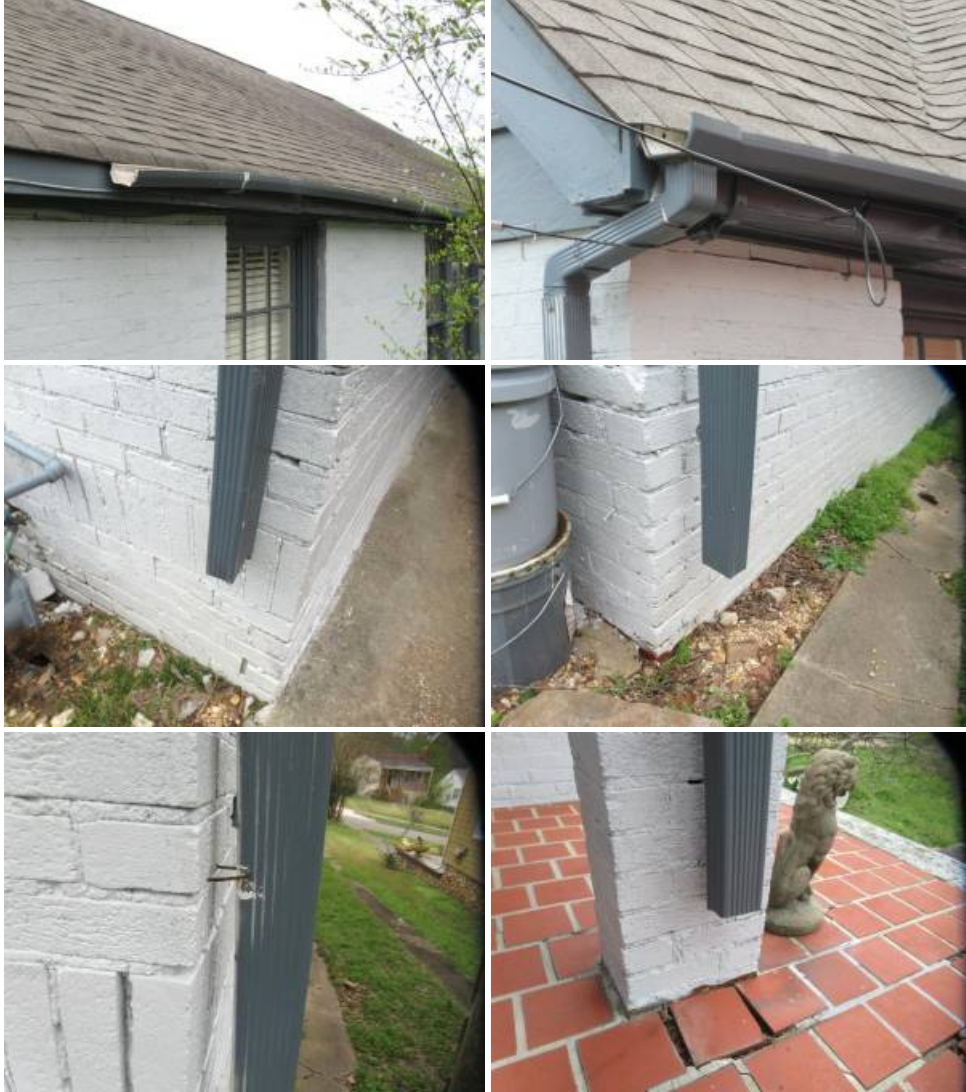
Gutters were partially installed. The rear gutter was damaged and partially missing. The end cap was missing at the right front. The elbows were missing from the downspouts, and downspouts were not properly secured. Gutter replacement is recommended.

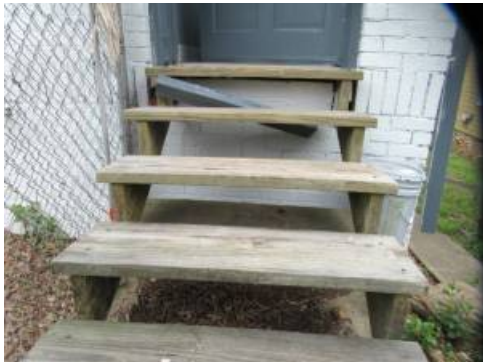
Settlement was noted at the front steps. The rear step treads were over-spanned, and an additional riser is recommended down the center of the steps.

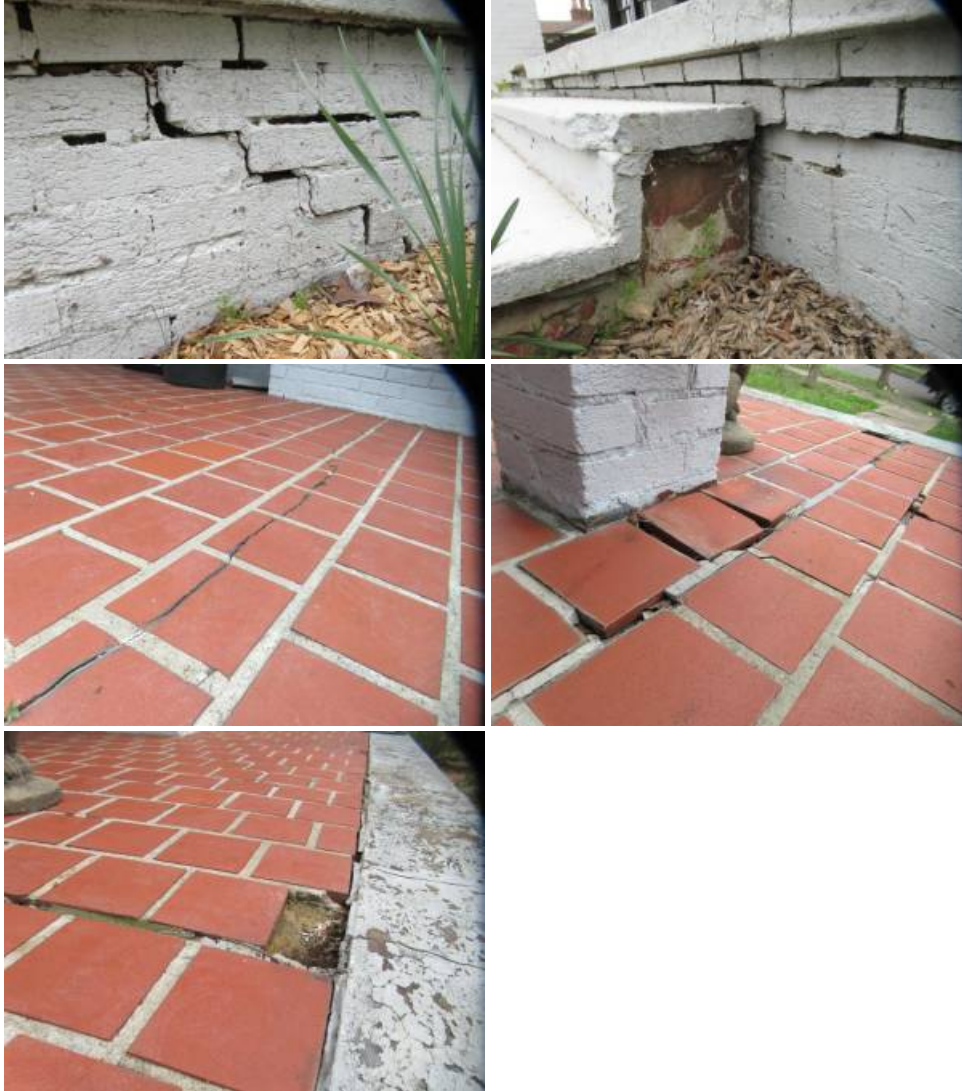
There was some typical settlement at the right-front corner of the porch. The front steps had settled causing damage to the front wall of the porch. There was cracking and damaged tile on the porch partially as a result of this movement. Structural repairs do not appear to be necessary at this time. Repairs to the tile are recommended to help prevent further damage from moisture.

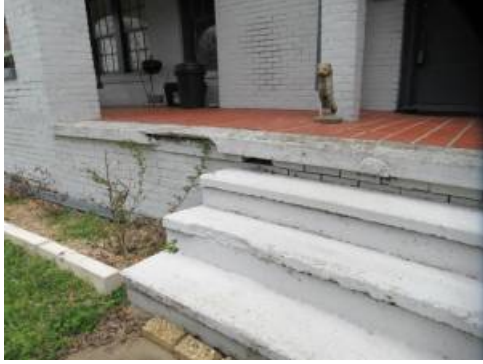
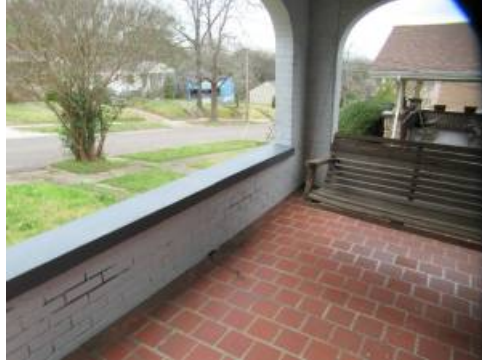
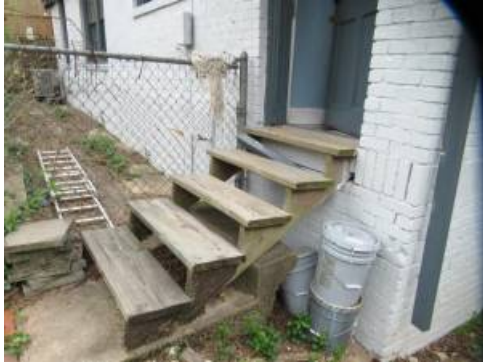
Railings are recommended for the elevated portions of the front porch and for the rear steps.

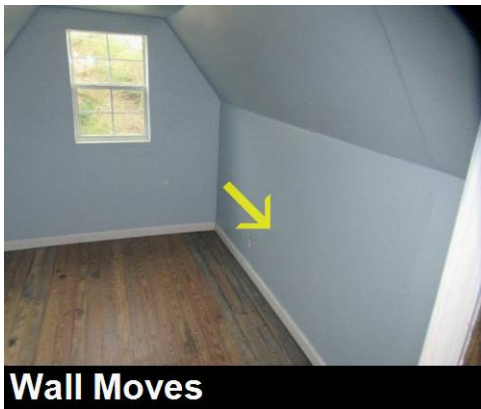
Wall Moves

Main structure type: Rafter system. Most of the roof structure was not visible due to finished walls. The left wall in the attic over the front porch had movement when the outlet tester was unplugged, and some structural repair is needed.

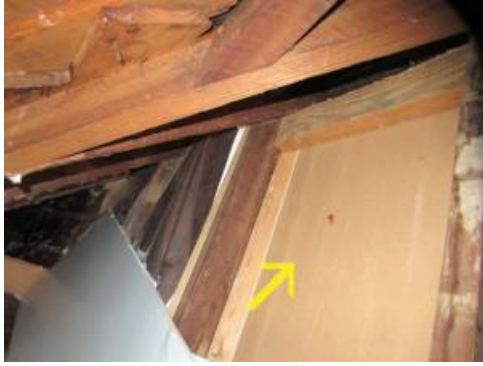
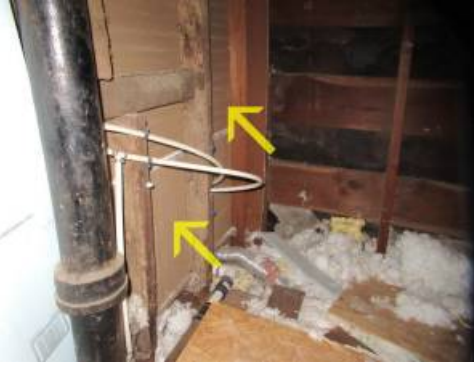
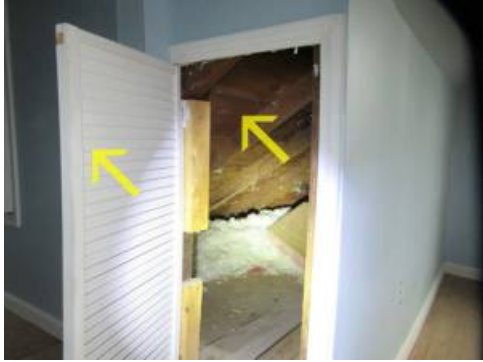
Insulation should be installed at the rafters in the closet at the left side of the attic due to a louvered door to this area. If the door is replaced it should be installed where missing on the wall. Insulation should be installed on the wall areas in the attic behind the upstairs bathroom.

Type: Fiberglass Batting and Cellulose-Blown. The insulation envelope was at the wall and ceiling areas in some locations and at the rafters at other areas. Insulation should be installed at the rafters in the closet at the left side of the attic due to a louvered door to this area. If the door is replaced it should be installed where missing on the wall. Insulation should be installed on the wall areas in the attic behind the upstairs bathroom.

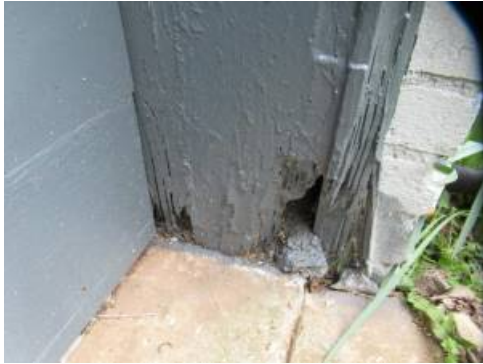
There was deteriorated wood at the crawlspace access that should be replaced.

Wall Materials: Brick and clay block. The crawl space was fully accessible, and was inspected by entering and crawling through. There was deteriorated wood at the crawlspace access that should be replaced.

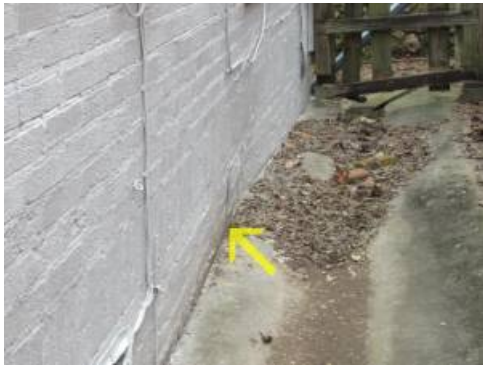
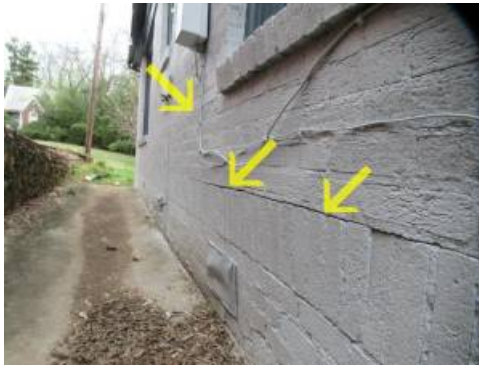
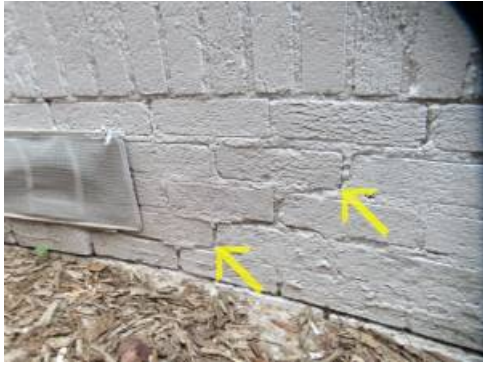
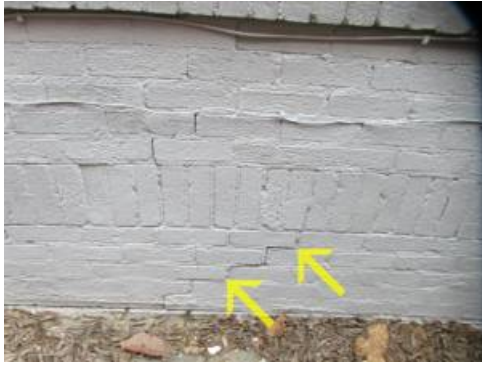
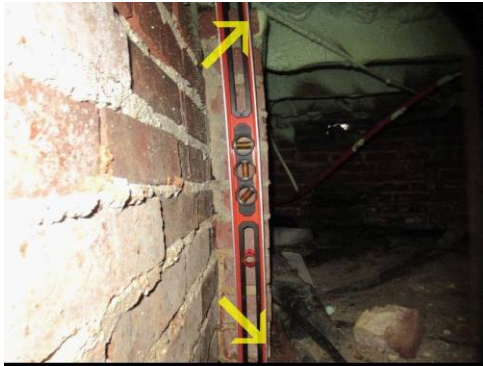
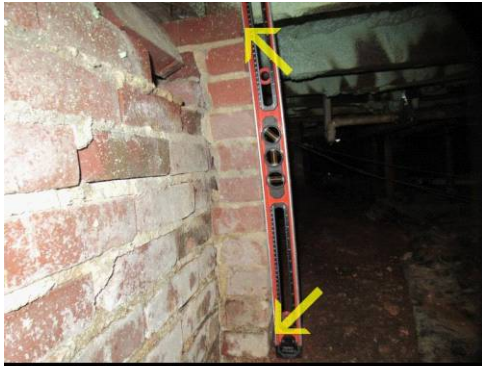
Right Wall

There was some severe racking in the right wall of the house as viewed from the exterior. The posts were leaning inward to a much lesser degree in crawlspace along the right wall and rear wall and some evidence of movement in the floor structure at there was outward movement in the left wall. This movement from the right combined with the movement from the rear could have been the cause for the bricks to come loose at the top of the walls. Some foundation repairs could be needed. Further evaluation by a structural engineer is recommended at this time to determine if structural reinforcement is needed.

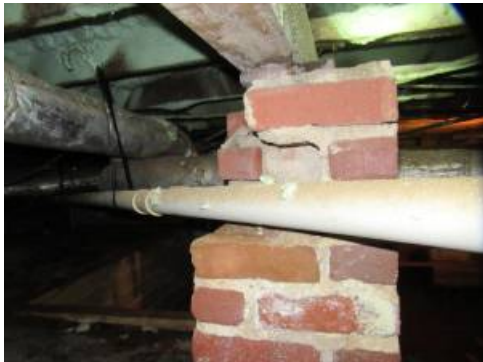
Type: Steel and Brick. One post was damaged to route a drain line, but no real issues were resulting.

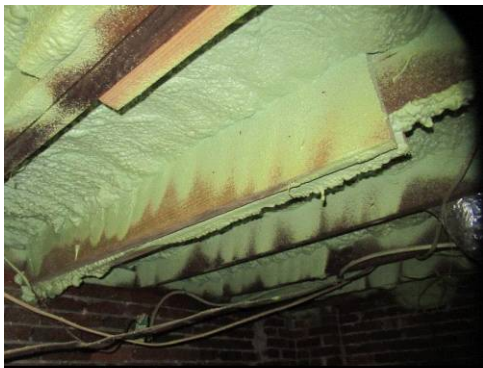
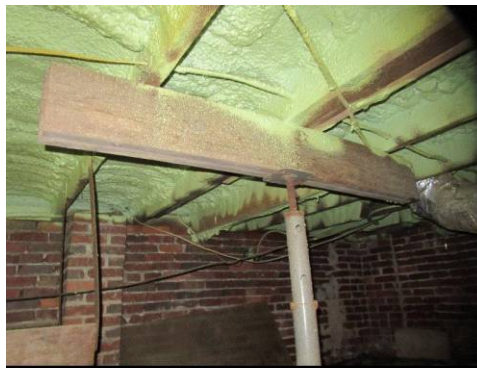
There was a cracked beam over one of the posts in the basement. A 2x4 with shim was installed to provide bearing to the damaged beam. This is inadequate, and an additional post is recommended in this area. There were a couple

joists that were improperly cut beside the stairs to the basement. A beam and posts are needed under these unsupported joists. Further evaluation and repairs as needed are recommended by a structural engineer or foundation specialist.

Type: Conventional wood framing. Subfloor was not fully visible. Under-floor insulation present; restricts viewing of subfloor areas. Joist repair and supplemental support was present at the left rear. The adequacy of this repair was not known. There was a cracked beam that was sagging at the right side. Some additional support was installed, and it appeared serviceable. There were some supports installed under the hall bathroom, and these appeared serviceable. There was a cracked beam over one of the posts in the basement. A 2x4 was installed to provide bearing to the damaged beam. This is inadequate, and an additional post is recommended in this area. There were a couple joists that were improperly cut beside the stairs to the basement. A beam and posts are needed under these unsupported joists. Further evaluation and repairs as needed are recommended by a structural engineer or foundation specialist.

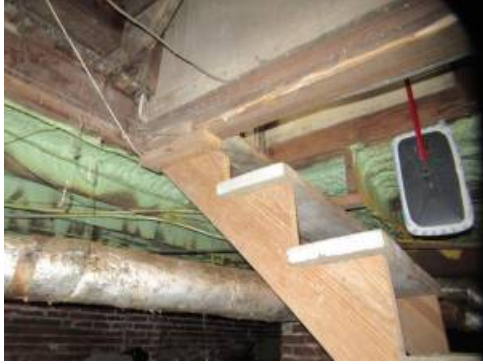
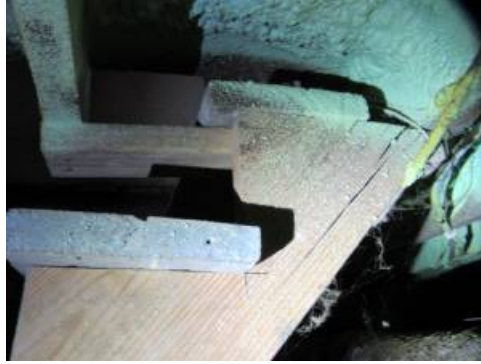
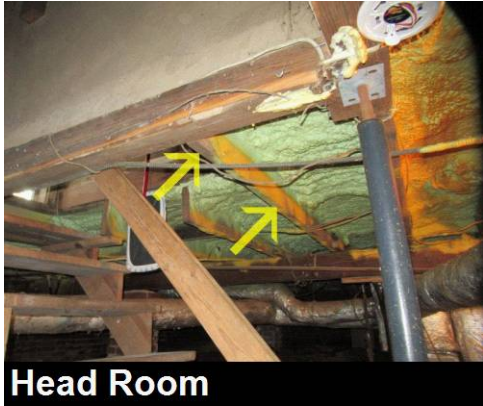
Head Room

The step risers did not have proper attachment at the top and were unsafe. Proper support is needed in this area. The stair well for the basement steps did not have proper head room of 6'8" at the floor joists, and at least one additional joist should be removed for a person to safely traverse the stairs and access the laundry area. Further evaluation and repairs as needed is recommended by a qualified contractor.

-
-
-
- The step risers did not have proper attachment at the top and were unsafe. Proper support is needed in this area. The stair well for the basement steps did not have proper head room of 6'8" at the floor joists, and at least one additional joist should be removed for a person to safely traverse the stairs and access the laundry area. Further evaluation and repairs as needed is recommended by a qualified contractor.

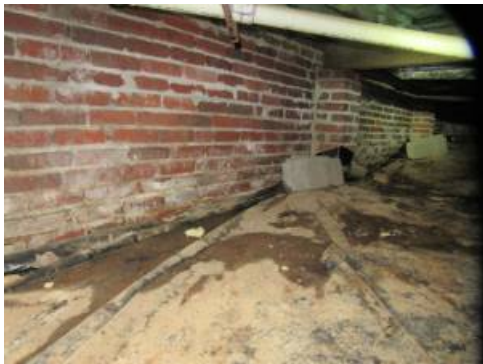
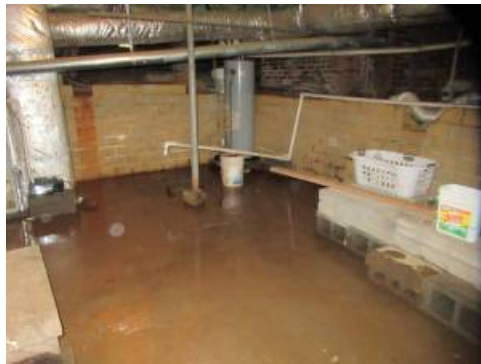
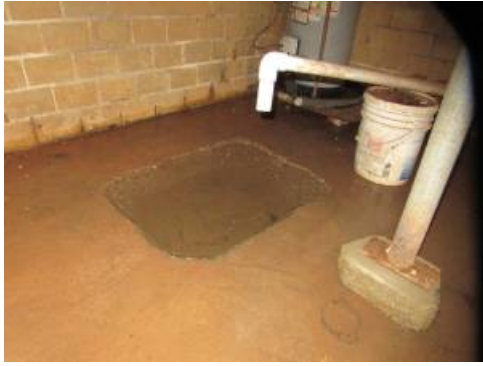
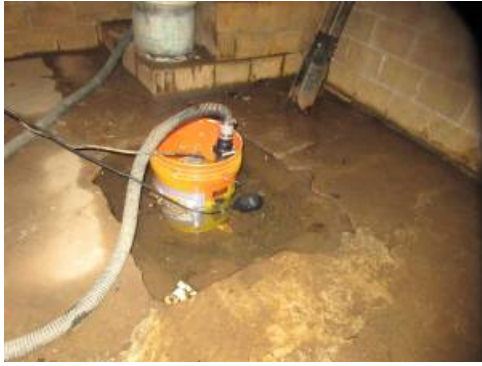
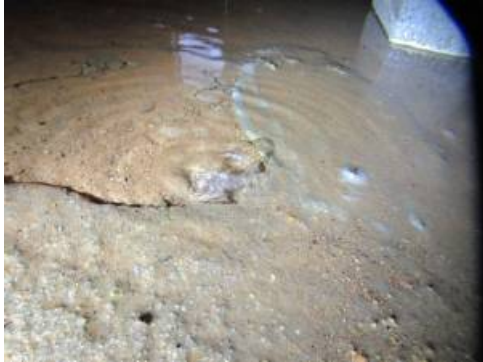
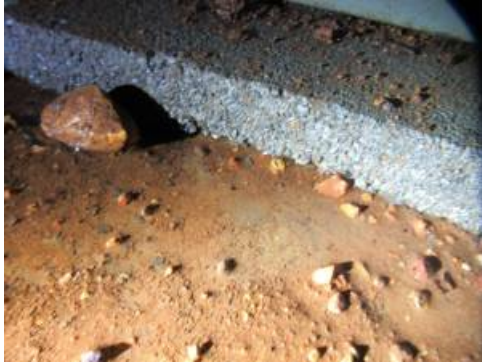
There was evidence of moisture penetration at the rear and right foundation walls, and there appeared to be water percolating up from beneath the concrete floor in the basement area. The basement area had been completely flooded and was still wet at the time of the inspection. A sump pump was present but was inadequate for handling the amount of water present, and additional measures are needed. Due to water originating from under the floor and the necessity for access to the laundry facility in this area an encapsulation system with two sump pumps is recommended. Further evaluation and repairs as needed is recommended by a foundation specialist.

- -
 -
 -
- There was evidence of moisture penetration at the rear and right foundation walls, and there appeared to be water percolating up from beneath the concrete floor in the basement area. The basement area had been completely flooded and was still wet at the time of the inspection. A sump pump was present but was inadequate for handling the amount of water present, and additional measures are needed. Due to water originating from under the floor and the necessity for access to the laundry facility in this area an encapsulation system with two sump pumps is recommended. Further evaluation and repairs as needed is recommended by a foundation specialist.

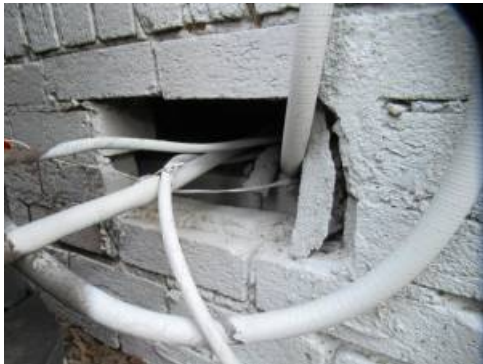
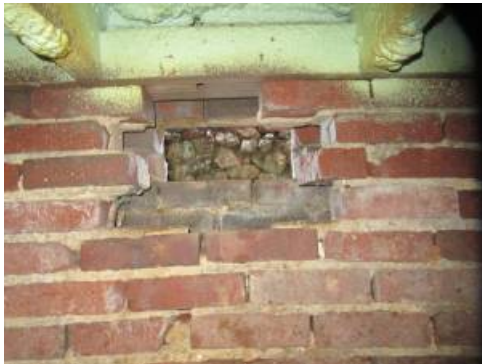
OK	MM	RR	SAF	
<i>Foundation Floor:</i>	<input type="checkbox"/>	<input checked="" type="checkbox"/>	<input type="checkbox"/>	<input type="checkbox"/>	Type: Soil. Concrete. A vapor barrier was present in part of the crawlspace but is recommended where missing. There was wood and possible animal droppings that should be removed from the crawl space area.
<i>Ventilation:</i>	<input type="checkbox"/>	<input type="checkbox"/>	<input checked="" type="checkbox"/>	<input type="checkbox"/>	Screens were damaged/missing for foundation vents. Replacement is recommended to help prevent rodent intrusion.

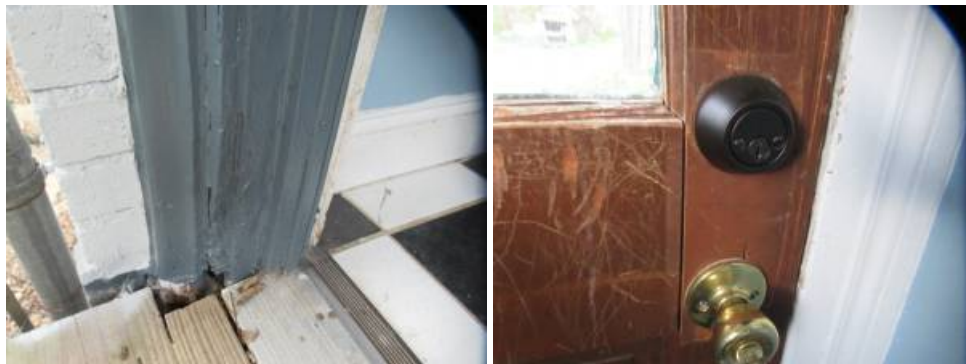
There was deteriorated wood in need of replacement at the rear door casing.

Double keyed dead bolts should be replaced with thumb-latch type where present as a fire safety enhancement. Modern construction standards indicate that glass panes located in doors should be tempered safety glass. Replacement should be considered as a safety improvement where this insignia is not present. There was deteriorated wood in need of replacement at the rear door casing.

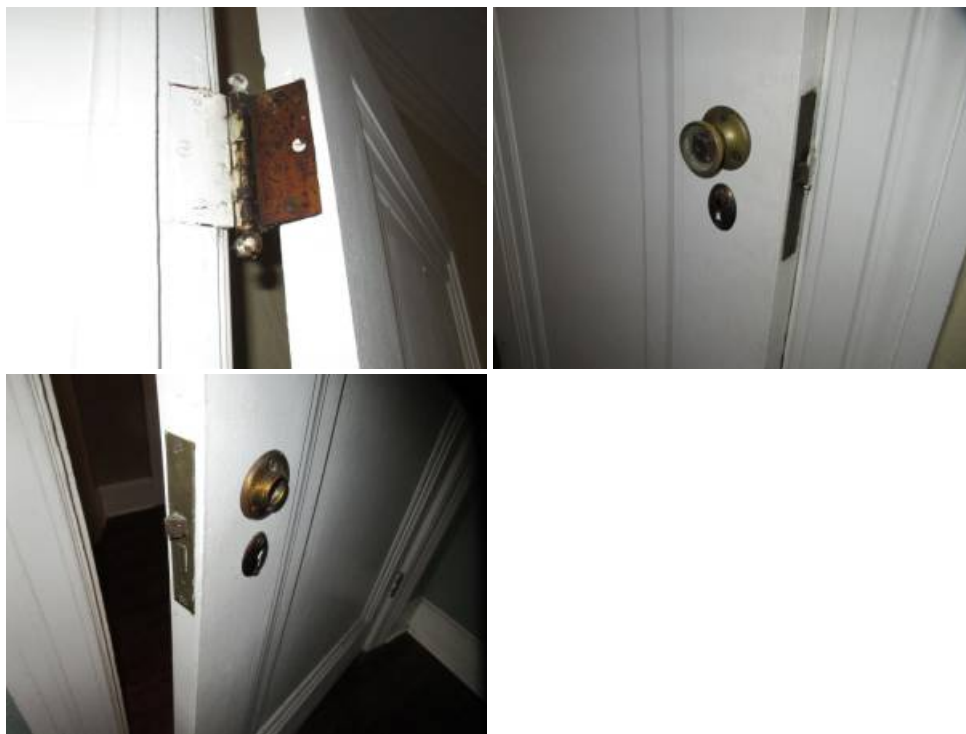
The hinges were loose on the door at the right-rear bedroom. The door hardware was damaged/missing in a couple locations. The doors rubbed at the floor and should be sanded to close properly at the rear bedroom and at the living room. The doors rubbed and did not close properly in a few locations most notably at the hall bathroom.

A representative sampling of doors throughout the house were tested. The hinges were loose on the door at the right-rear bedroom. The door hardware was damaged/missing in a couple locations. The doors rubbed at the floor and should be sanded to close properly at the rear bedroom and at the living room. The doors rubbed and did not close properly in a few locations most notably at the hall bathroom.

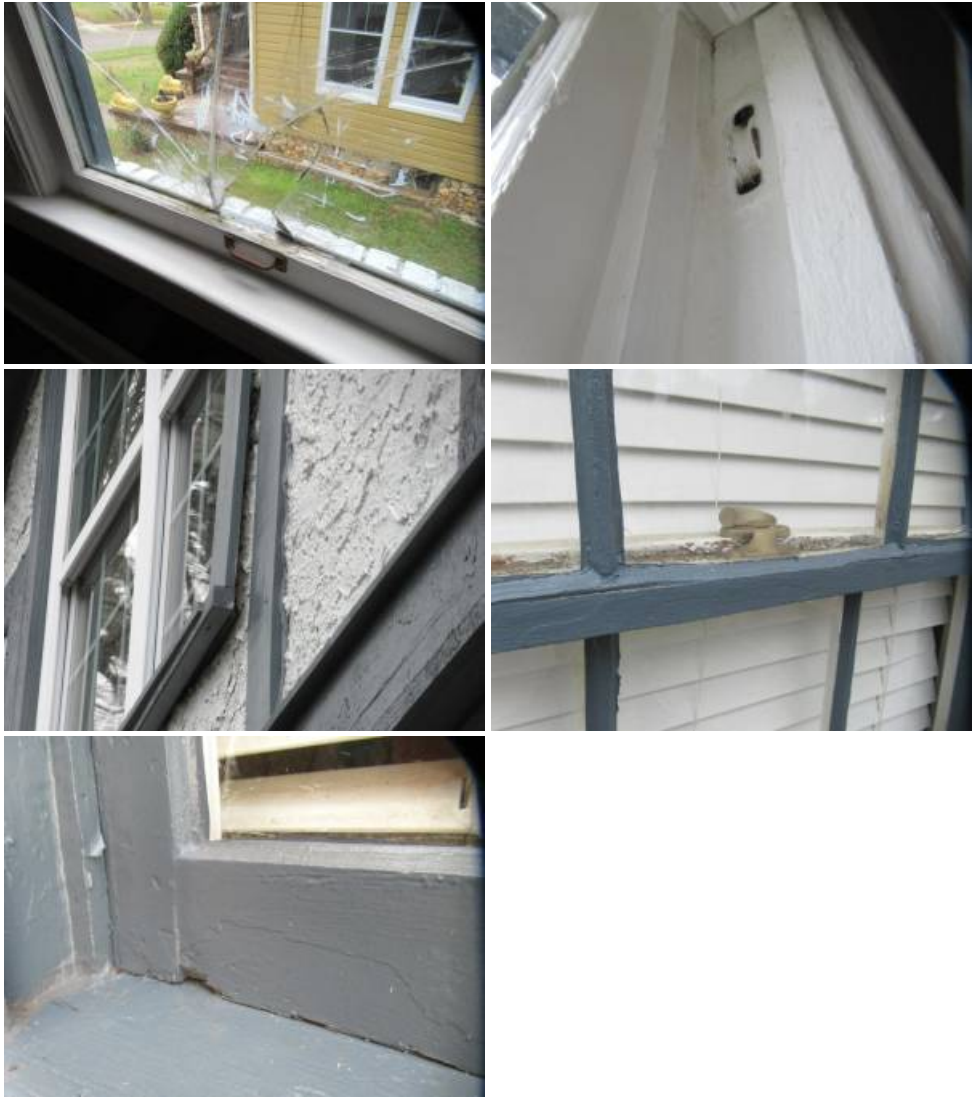
There were several windows that were painted shut (and slightly open), and window sashes would not latch or open. There was a cracked/broken window in need of replacement in the dining room. There was deteriorated wood noted on window sashes as viewed from the exterior in a couple locations, and at least one window sash was sagging (front) and would not latch. There were broken sash cords, or non-functioning balance mechanisms (weights). The upstairs window at the left side of the house was pushed out at the bottom front and did not appear to be properly installed.

A representative sampling of windows throughout the house were tested. There were several windows that were painted shut (and slightly open), and window sashes would not latch or open. There was a cracked/broken window in need of replacement in the dining room. There was deteriorated wood noted on window sashes as viewed from the exterior in a couple locations, and at least one window sash was sagging (front) and would not latch. There were broken sash cords, or non-functioning balance mechanisms (weights). The upstairs window at the left side of the house was pushed out at the bottom front and did not appear to be properly installed.

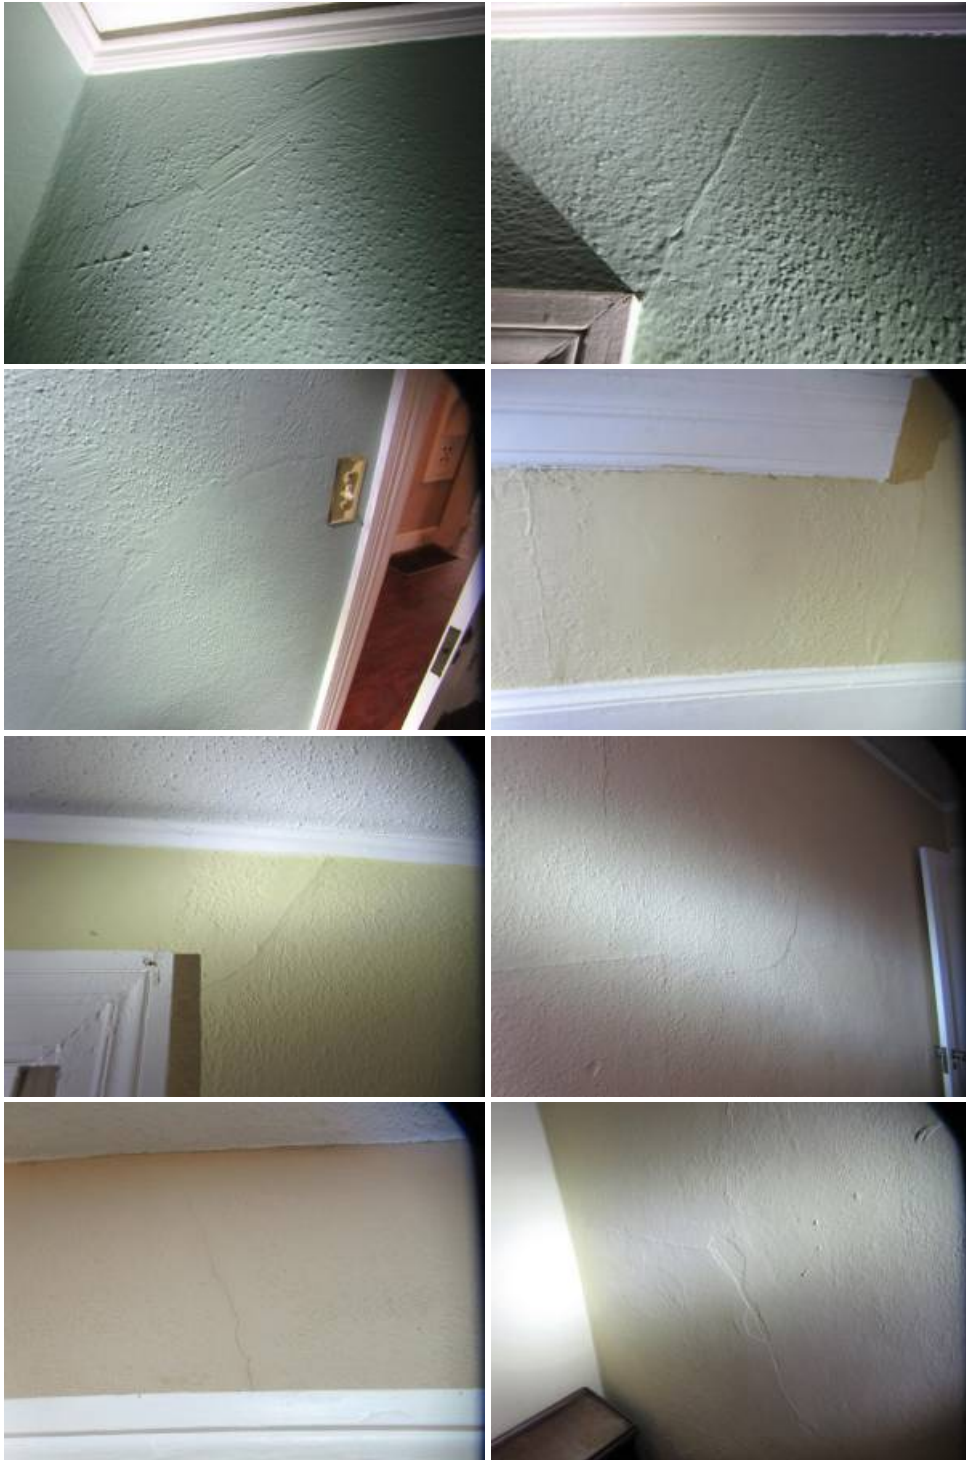
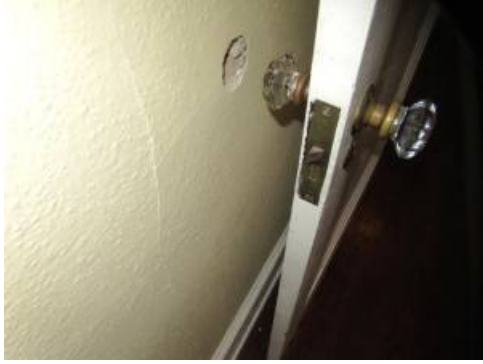
There were stress cracks due to settlement noted to the interior walls and ceilings in several locations. Cosmetic repairs and monitoring for further movement is

recommended for this type of crack. The door stops should be replaced where missing or damaged to help prevent damage to the walls. Minor drywall repair or patching is needed for doorknob damage at the rear bedroom.

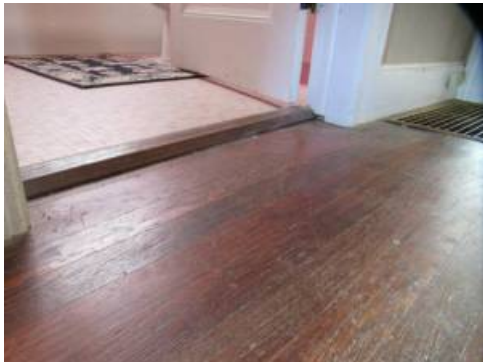
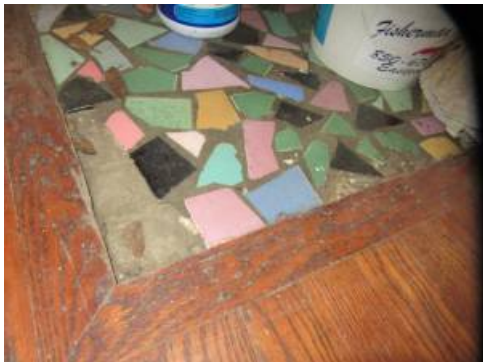
General Condition: The floor did not appear to be level in a few locations. There were a few cracked and missing tiles noted in the hall bathroom and at the hearth extension for the fireplace and a cracked tile in the kitchen.

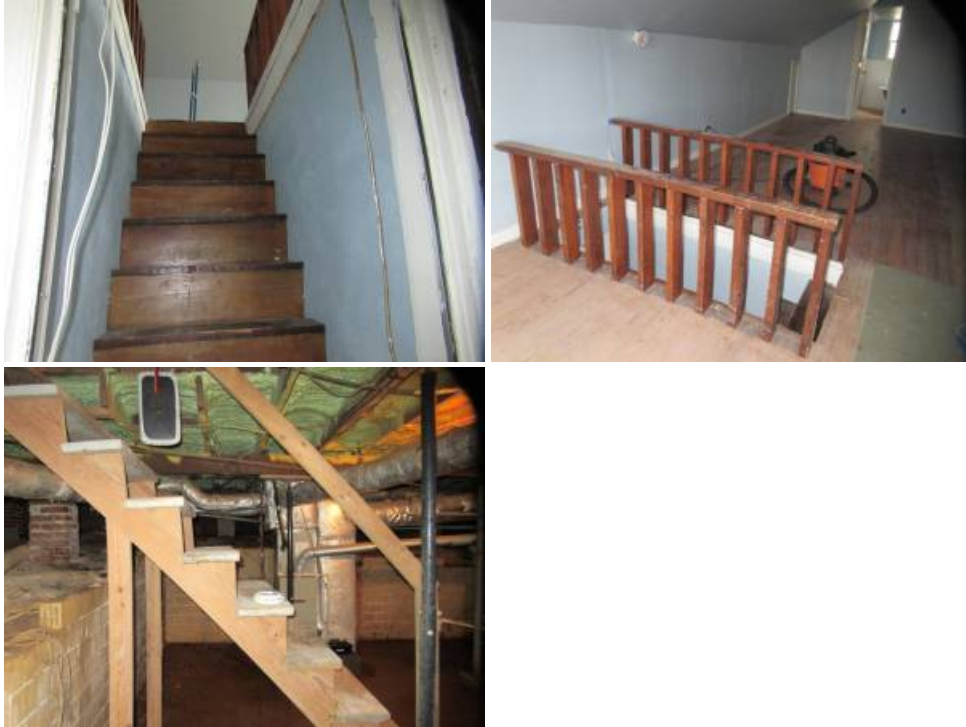
It is now recommended that railings have balusters spaced no more than four inches apart as a safety enhancement at the basement stairs. The railing system

is recommended to be 42 inches in height as a safety upgrade at the upstairs landing, and a graspable hand rail is recommended for the upper stairway as a safety upgrade.

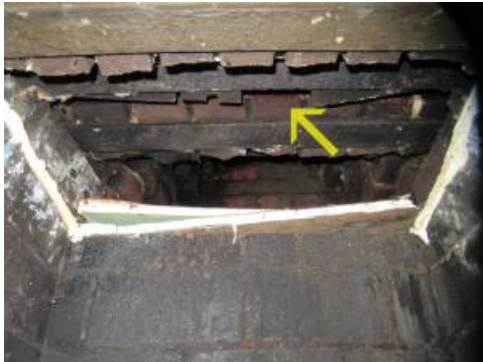
Type: Masonry. There was no damper present for the fireplace. The smoke chamber was located behind the firebox, and there was evidence of smoke roll-out on the brick above the firebox (behind the fireplace surround). This fireplace did not appear to be safe for use. Evaluation and repairs as needed is recommended by a qualified chimney specialist prior to use.

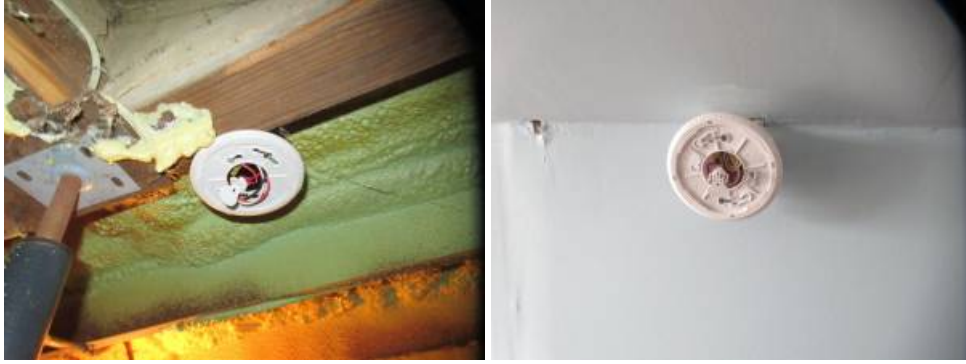
The smoke detectors were removed/missing and should be replaced in the basement and upstairs, and a carbon monoxide detector is recommended upstairs. Smoke detectors over ten years old and ionization detectors are recommended to be replaced with new photoelectric smoke detectors.

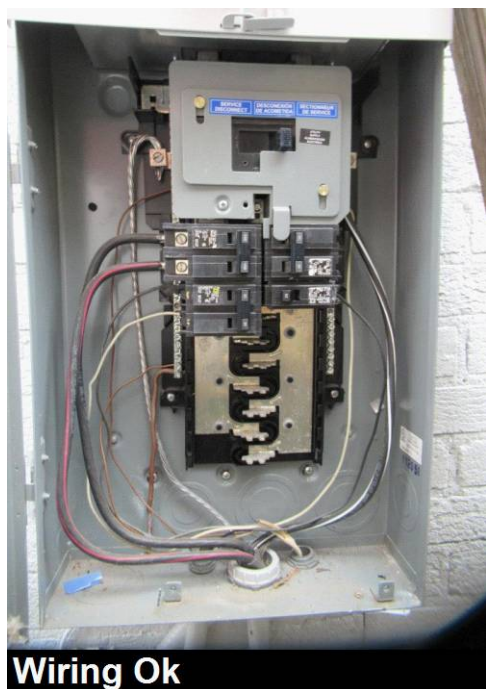
Main Panel Observations:
 The 30 amp breaker was for the condensing unit and appeared serviceable. The panel was not labeled.

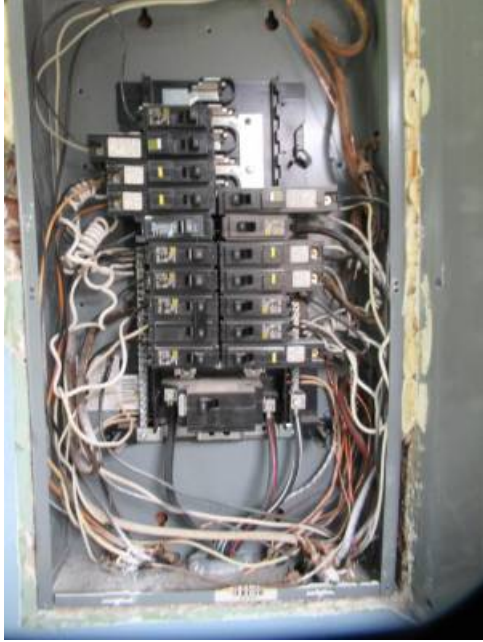
Subpanel Location: Kitchen. There appeared to be over-fusing (breaker too large for wire size) noted on at least one 20 amp circuit in the panel. This poses a potential safety hazard, and correction is needed. Further evaluation and corrections as needed are recommended by a licensed electrician.

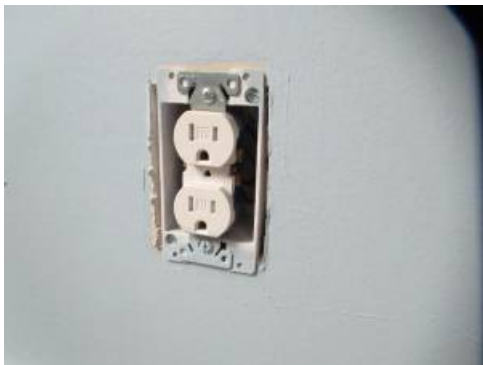
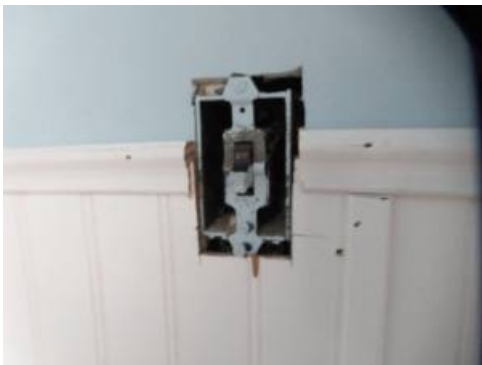
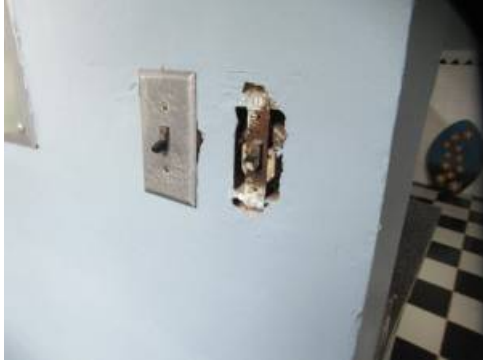
<i>General:</i>	<input type="checkbox"/>	<input type="checkbox"/>	<input type="checkbox"/>	<input checked="" type="checkbox"/>	A representative sampling of switches, fixtures and outlets were checked. Cover plates are needed where missing or damaged for switches and outlets.
-----------------	--------------------------	--------------------------	--------------------------	-------------------------------------	--

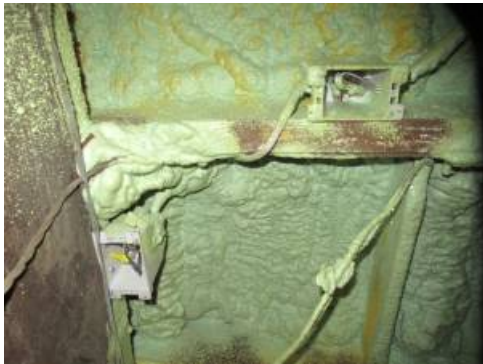
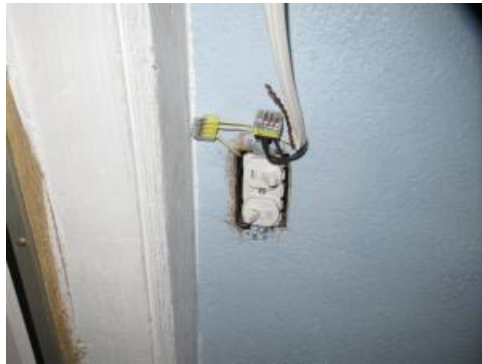
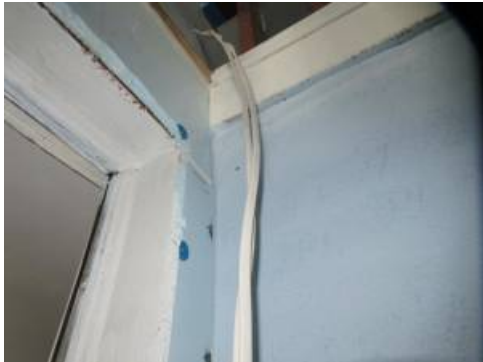
Ground fault circuit interrupter (GFCI) outlets were present in most recommended locations. However, there were a couple outlets that were not GFCI protected in the basement and over the kitchen counter by the door.

Cover plates are recommended where missing on junction boxes in the basement. The wiring in the stairway should be properly secured and routed into the switch box through a knock-out so a cover plate can be installed.

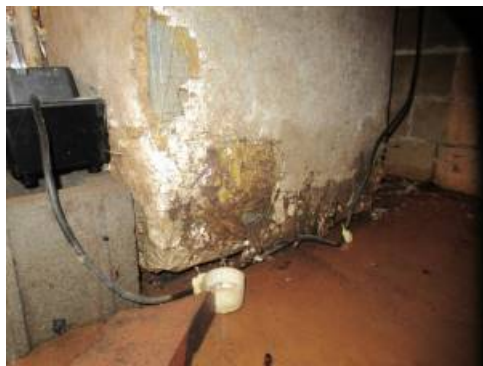
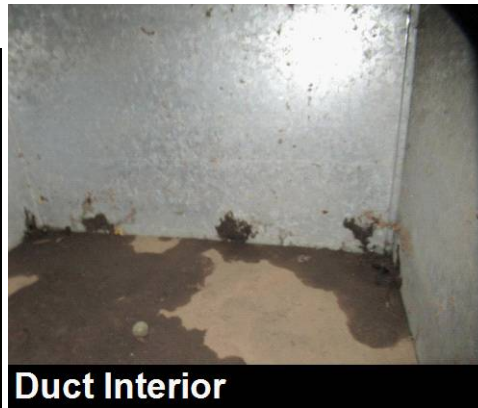
Duct Interior

There was some damaged/missing insulation on the ductwork in the crawlspace, and there was water damage on the insulation for the return-air duct beside the air handler. Some water had entered the plenum/duct in this area, but

it appeared to be okay at the interior. Further evaluation and repairs are recommended by a licensed HVAC contractor.

The distribution system was ducts with registers. There was some damaged/missing insulation on the ductwork in the crawlspace, and there was water damage on the insulation for the return-air duct beside the air handler. Some water had entered the plenum/duct in this area, but it appeared to be okay at the interior. Further evaluation and repairs are recommended by a licensed HVAC contractor.
