Total Home Inspection LLC

Inspection Report

Client: Eric Fogle
825 81st St S
Birmingham, AL 35206

Report: 02fogle2619

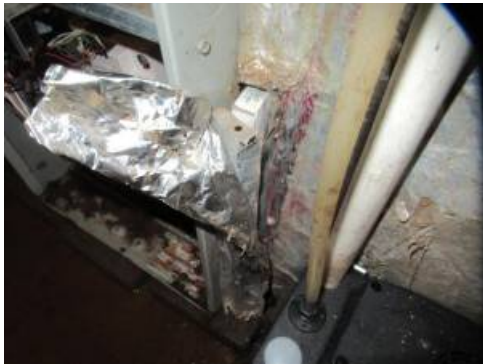
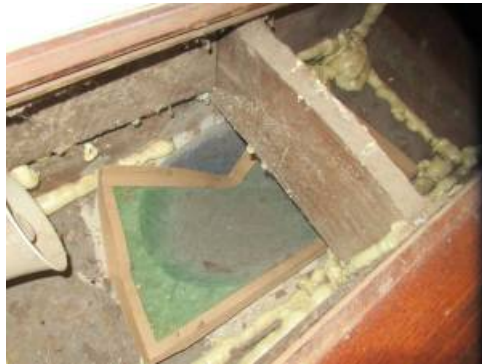
There was a filter installed at the furnace unit and at the return air register. This should be corrected as it can restrict air-flow. Removal of the filter at the floor is recommended since there was no hold-down and the filter was bent in allowing airflow around the filter. The cover for the air filter in the basement was held with tape. This is inadvisable, and a cover should be installed that is functional without the need for tape.

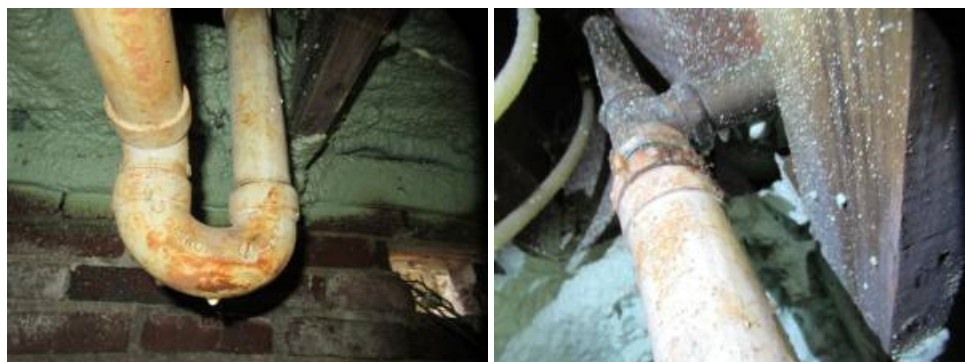
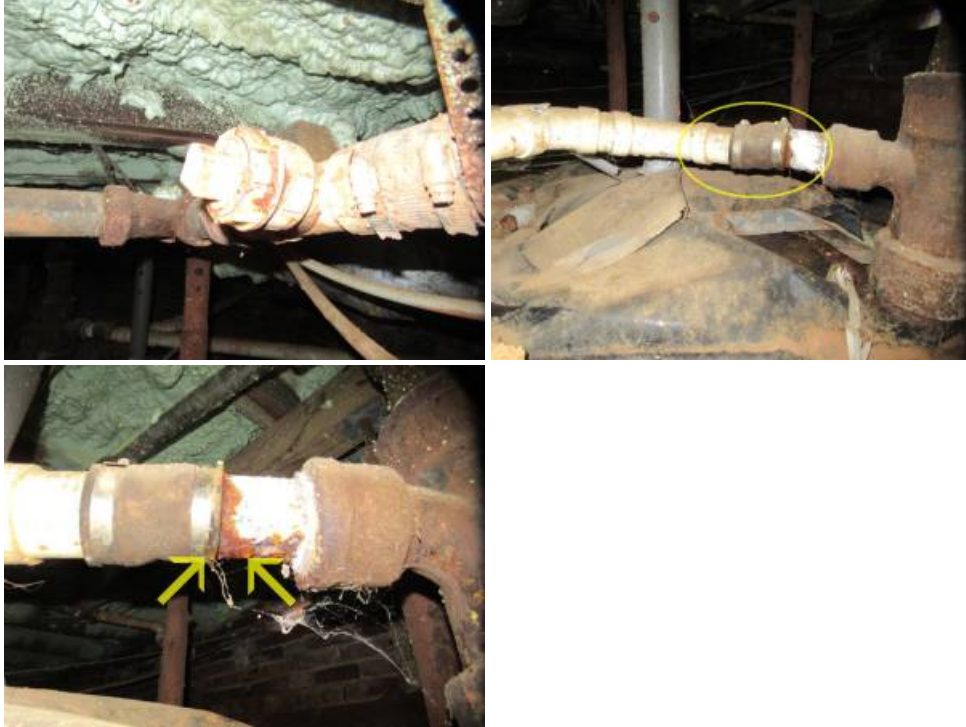
The drain line for the hall bathtub was leaking into the crawlspace. There was a leak at the clean-out cap under the hall bathroom. There was a PVC drain line (from the kitchen and laundry) that was not properly supported and was sagging at the connection to the galvanized pipe. This coupling was leaking, and the galvanized pipe was rusted and in need of replacement. Further evaluation and repairs as needed is recommended by a licensed plumber.

<i>Materials:</i>	<input checked="" type="checkbox"/>	<input type="checkbox"/>	<input type="checkbox"/>	<input type="checkbox"/>	PVC, Cast Iron, and Galvanized.
<i>Condition:</i>	<input type="checkbox"/>	<input type="checkbox"/>	<input checked="" type="checkbox"/>	<input type="checkbox"/>	Plumbing waste lines were not fully visible. The drain line for the hall bathtub was leaking into the crawlspace. There was a leak at the clean-out cap under the hall bathroom. There was a PVC drain line (from the kitchen and laundry) that was not properly supported and was sagging at the connection to the galvanized pipe. This coupling was leaking, and the galvanized pipe was rusted and in need of replacement. Further evaluation and repairs as needed is recommended by a licensed plumber.

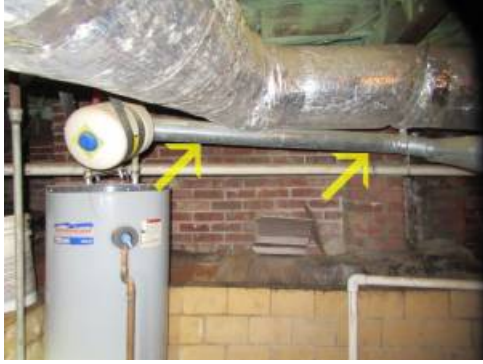
The flue for the water heater did not have a proper rise. This is a safety hazard and should be corrected by a qualified HVAC contractor.

<i>Location:</i>	Basement.				
<i>Power Source:</i>	<input checked="" type="checkbox"/>	<input type="checkbox"/>	<input type="checkbox"/>	<input type="checkbox"/>	Gas.
<i>Capacity:</i>	40 Gallons.				
<i>Condition:</i>	<input checked="" type="checkbox"/>	<input type="checkbox"/>	<input type="checkbox"/>	<input type="checkbox"/>	Manufactured 2011. Water shutoff valve: Installed. Expansion tank: installed.
<i>Tpr Valve</i>	<input checked="" type="checkbox"/>	<input type="checkbox"/>	<input type="checkbox"/>	<input type="checkbox"/>	TPR valve and discharge pipe: Installed.
<i>Burners & Flue</i>	<input type="checkbox"/>	<input type="checkbox"/>	<input type="checkbox"/>	<input checked="" type="checkbox"/>	The flue for the water heater did not have a proper rise. This is a safety hazard and should be corrected by a qualified HVAC contractor.

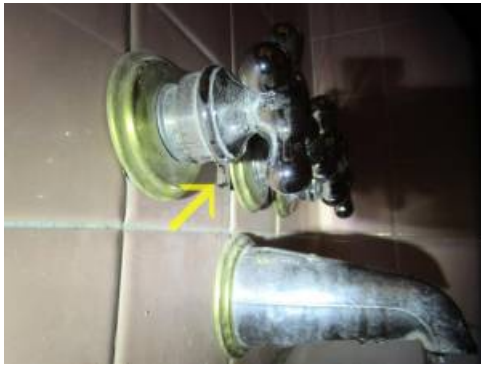
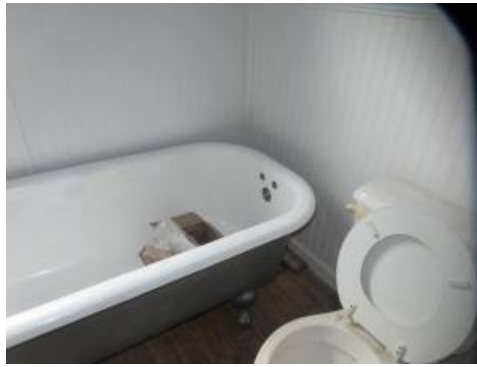
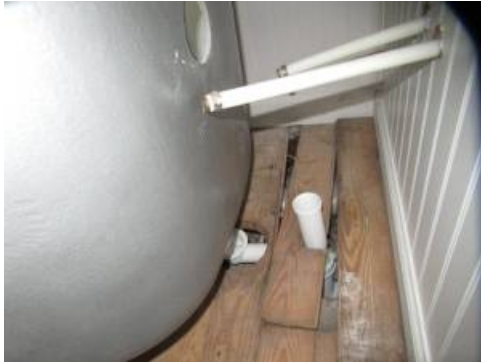
Minor leakage was noted at faucet handle for the bathtub in the hall bathroom. The plumbing was not installed to the bathtub in the upstairs bathroom. The bathtub in the hall bathroom was not draining properly. Further evaluation and repairs as needed are recommended by a licensed plumber.

<i>Condition</i>	<input type="checkbox"/>	<input type="checkbox"/>	<input checked="" type="checkbox"/>	<input type="checkbox"/>	Minor leakage was noted at faucet handle for the bathtub in the hall bathroom. The plumbing was not installed to the bathtub in the upstairs bathroom. The bathtub in the hall bathroom was not draining properly. Further evaluation and repairs as needed are recommended by a licensed plumber.
------------------	--------------------------	--------------------------	-------------------------------------	--------------------------	--
