Total Home Inspection LLC

Inspection Report

Client: Edgar Nunez
822 Beacon Pkwy E Unit A
Birmingham, AL 35209

Report: 06nunez1919

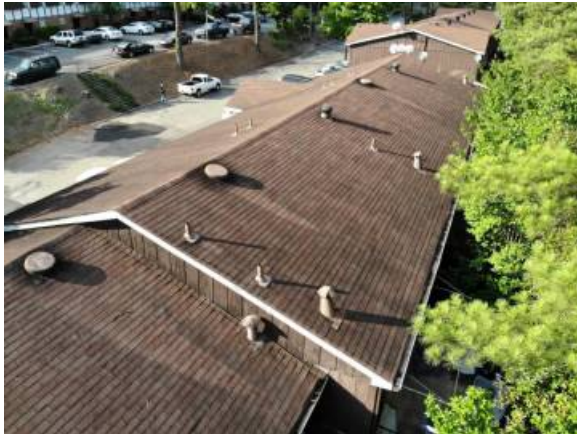
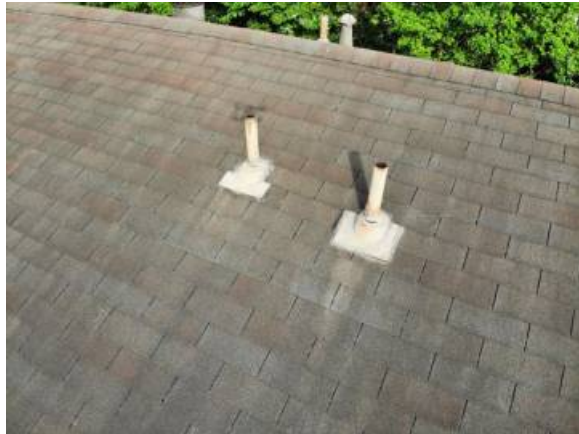
Roof:

Type & Access:
 Roof Style: Gable. Roof Access: Viewed from ground with binoculars and with a drone. Material: Asphalt Shingles. Number of layers: Unknown.

Roof Condition:
☒ ☐ ☐ ☐ The visible portions of the roof and flashings appeared serviceable.

Flashings:
☒ ☐ ☐ ☐ Plumbing vents and roof penetrations appear serviceable.

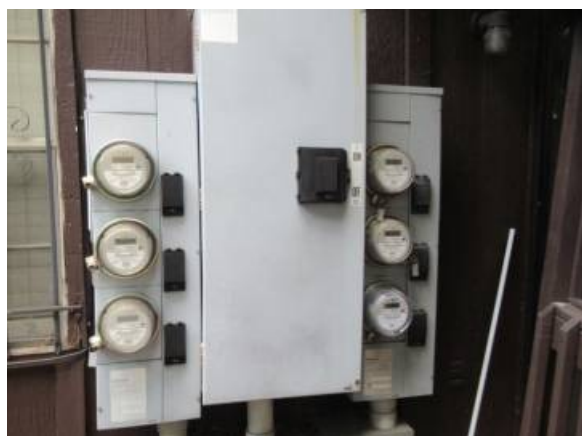
Electrical Distribution Panels:

Main Panel Location:	<input checked="" type="checkbox"/>	<input type="checkbox"/>	<input type="checkbox"/>	<input type="checkbox"/>	Location: Exterior at meter. Amps: 125. Main disconnect was present. This was a shared panel with other units, and the panel was not opened.
----------------------	-------------------------------------	--------------------------	--------------------------	--------------------------	--
