Total Home Inspection LLC

Inspection Report

Client: Eric Fogle
825 81st St S
Birmingham, AL 35206

Report: 02fogle2619

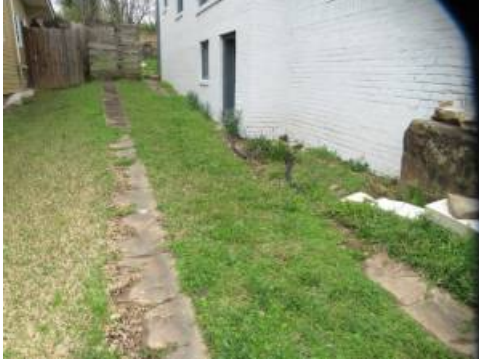
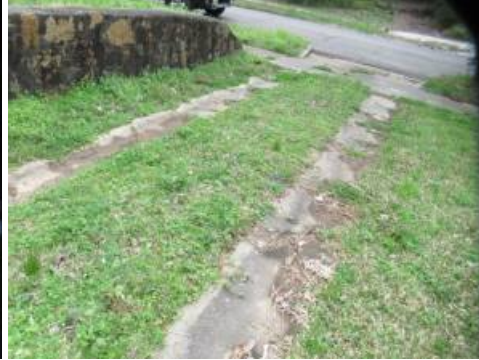
Driveway:

Type: Concrete. Concrete repair or replacement is due at the driveway.

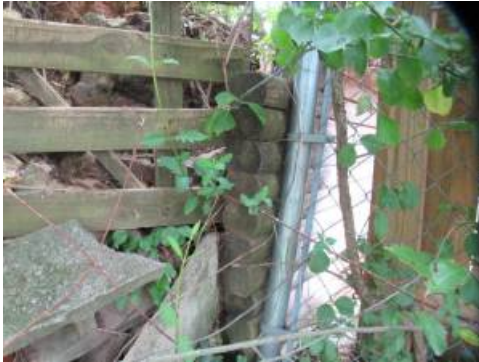
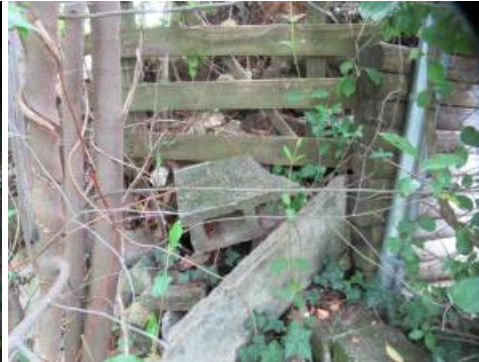
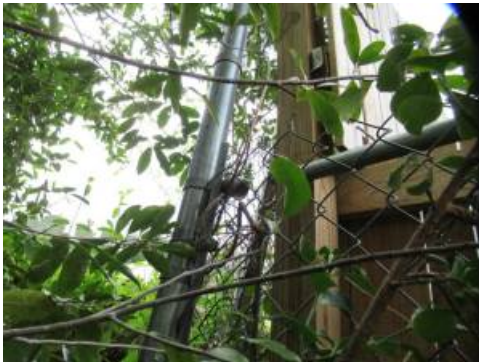
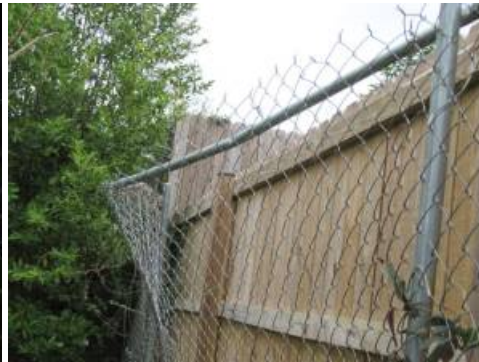
Condition:

Type: Wood, Chain link, and Wire. There was a wood retaining wall (possibly on the neighboring property) and construction debris leaning against the right-rear corner of the fence and causing damage. This wall should be replaced and independently supported, and the debris should be removed as a safety precaution. Fence repairs or replacement should be made once it is free of these encumbrances.

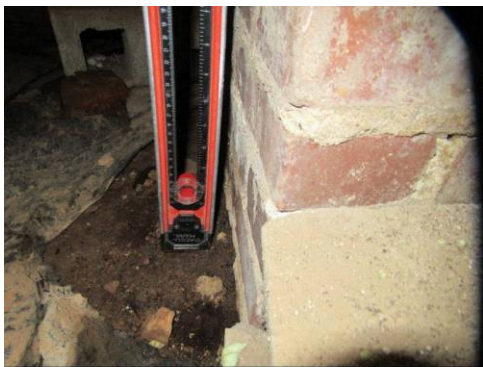
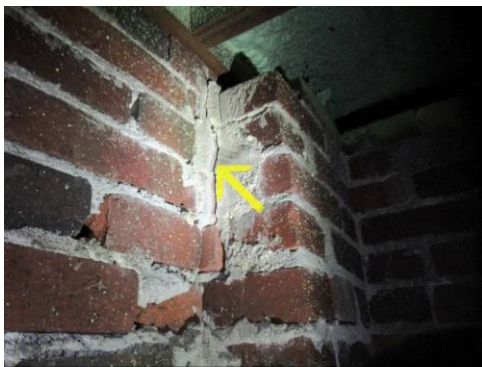
Right Wall

There was some severe racking in the right wall of the house as viewed from the exterior. The posts were leaning inward to a much lesser degree in crawlspace along the right wall and rear wall and some evidence of movement in the floor structure at there was outward movement in the left wall. This movement from the right combined with the movement from the rear could have been the cause for the bricks to come loose at the top of the walls. Some foundation repairs could be needed. Further evaluation by a structural engineer is recommended at this time to determine if structural reinforcement is needed.

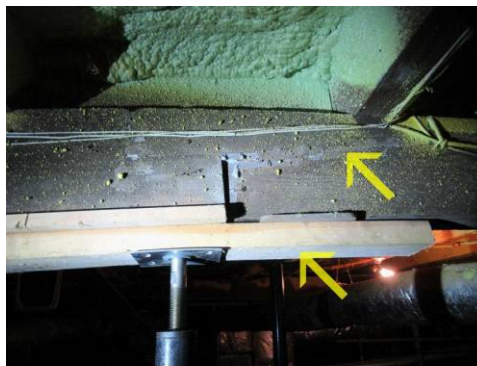
There was a cracked beam over one of the posts in the basement. A 2x4 with shim was installed to provide bearing to the damaged beam. This is inadequate, and an additional post is recommended in this area. There were a couple

Supports Ok

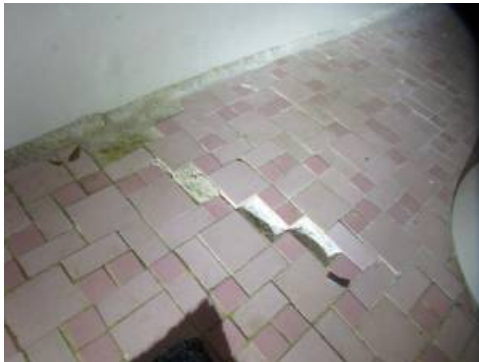
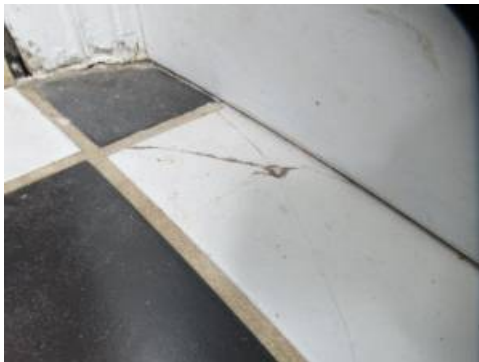
General Condition: The floor did not appear to be level in a few locations. There were a few cracked and missing tiles noted in the hall bathroom and at the hearth extension for the fireplace and a cracked tile in the kitchen.

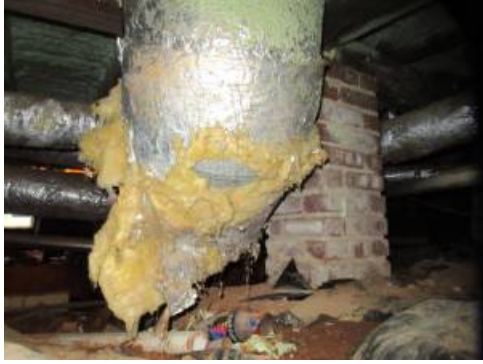
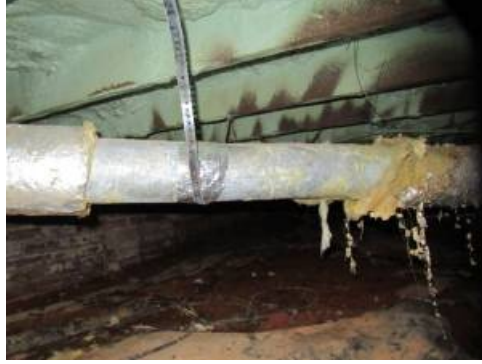
Duct Interior

There was some damaged/missing insulation on the ductwork in the crawlspace, and there was water damage on the insulation for the return-air duct beside the air handler. Some water had entered the plenum/duct in this area, but

it appeared to be okay at the interior. Further evaluation and repairs are recommended by a licensed HVAC contractor.

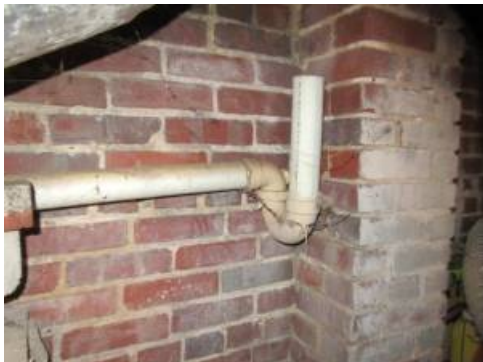
<input type="checkbox"/>	<input checked="" type="checkbox"/>	<input type="checkbox"/>	<input type="checkbox"/>	Standpipe not tested. There was an unused trap in the basement laundry that should be properly capped off to prevent sewer gasses from entering the house if it remains unused.
--------------------------	-------------------------------------	--------------------------	--------------------------	---
